Bridge Inspection Report

Rd 10 Bridge Patterson Drain

Road Name: Road 10
Site ID: 014
Structure Type: Solid Slab
Owner: Town of Kingsville
Built: 1918
Length: 3.9 m
Width: 7.4 m
Spans: 1
Spans Arrange: 1 - 3.8
Feature Under: Water
Crossing: Patterson Drain
Location: 2.45km East of Graham Sideroad

Inspection Date: August-25-17
Inspector: Steve Reid, C.E.T.
Assistant: Brad Lair, Eng Student

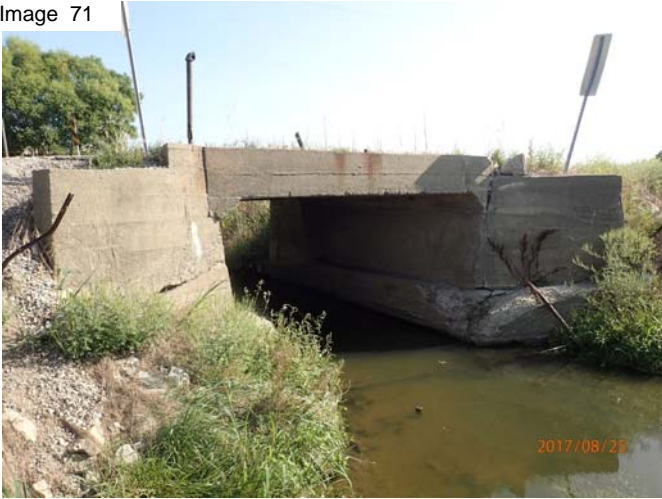
Image 71

South elevation

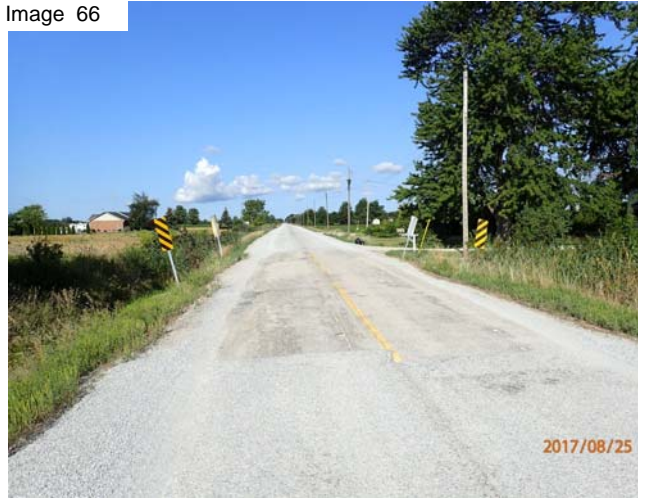
Image 66

East approach

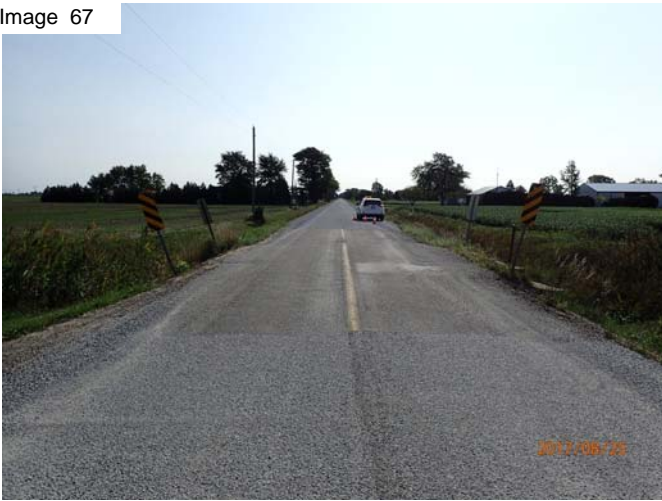
Image 67

West approach

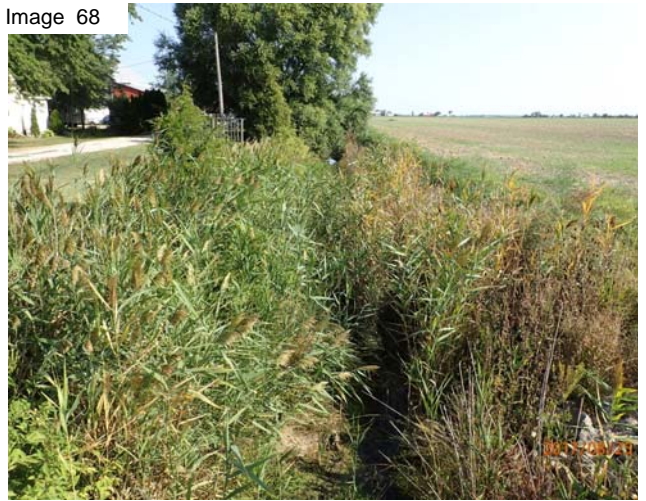
Image 68

Downstream channel north

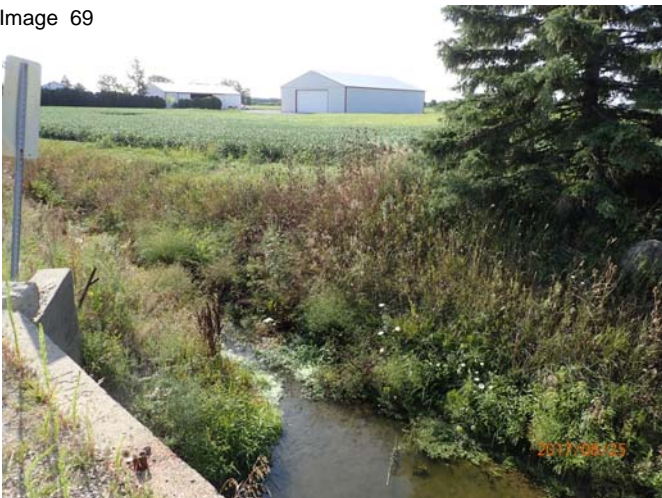
Image 69

Upstream channel south

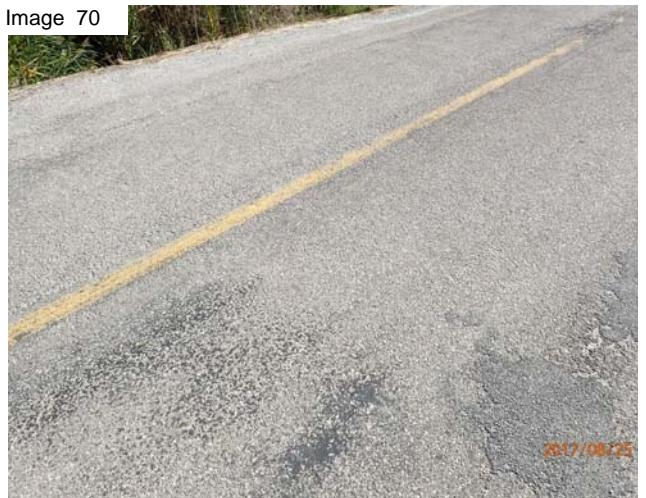
Image 70

Asphalt Wear Surf (1)	Defects 0.0%
Wear Surface	Damage 0.0%
Length: 3.9 m	Maintenance None
Width: 6.2 m	Capital Rec. None
Height:	<i>No concerns.</i>

Typ wearing surface over structure

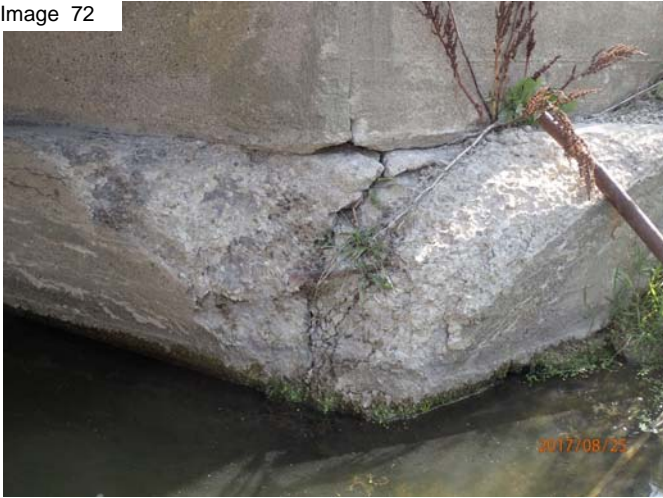
Image 72

Protected ECRC Deck (1)	Defects 0.0%
Deck Surface	Damage 10.0% Moderate Disintegration
Length: 3.9 m	Maintenance None
Width: 7.4 m	Capital Rec. None
Height:	<i>Covered with asphalt and approximately 300mm of granular fill. Given the age and soffit condition assume some damage to deck top. Bridge was widened likely in the 1950's width of bridge is still inadequate for the current travelled road.</i>

SE corner disintegration damage

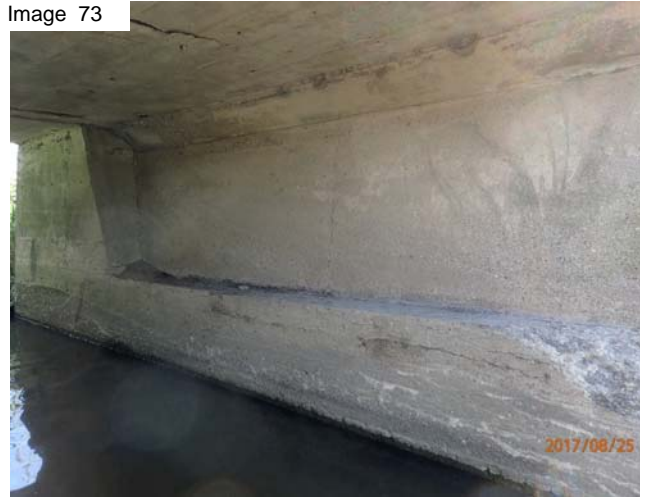
Image 73

RC Abutment Wall (2)	Defects 60.0% Major Scaling
Abutment Stem	Damage 1.0% Major Cracking
Length: 7.4 m	Maintenance None
Width:	Capital Rec. None
Height: 1.4 m	<i>Major scaling. Wide crack in west wall at north extension.</i>

East abutment wall

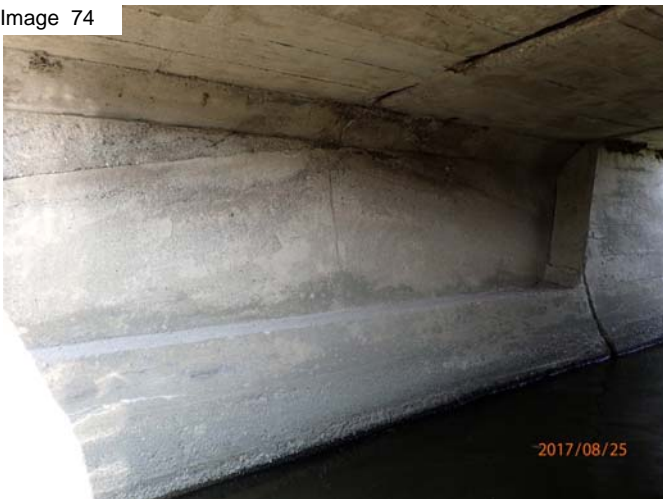
Image 74

West abutment wall

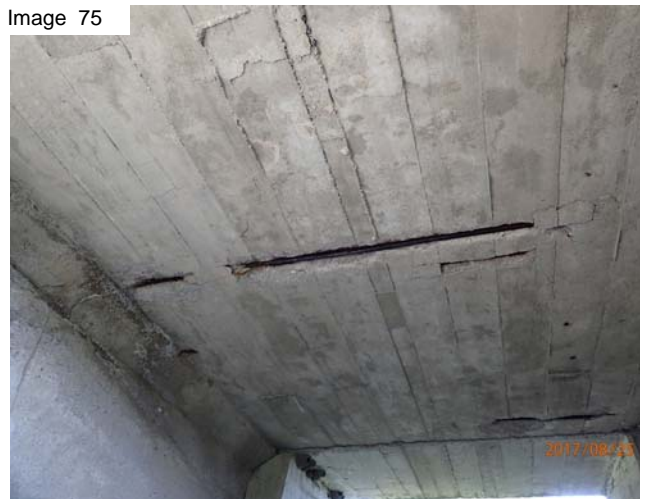
Image 75

Soffit (1)	Defects 60.0% Major Scaling
Deck Soffit	Damage 20.0% Moderate Delamination, Moderate Spalling
Length: 3.9 m	Maintenance None
Width: 6.2 m	Capital Rec. None
Height:	<i>Major scaling throughout. Spalled and delaminated areas.</i>

Typ soffit detail

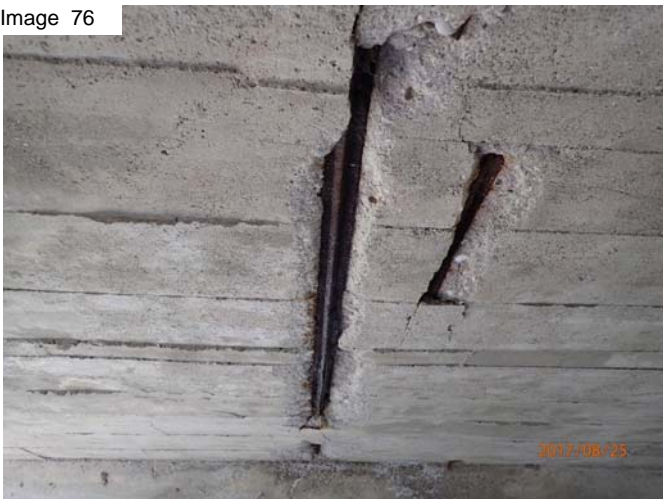
Image 76

Spalls in soffit

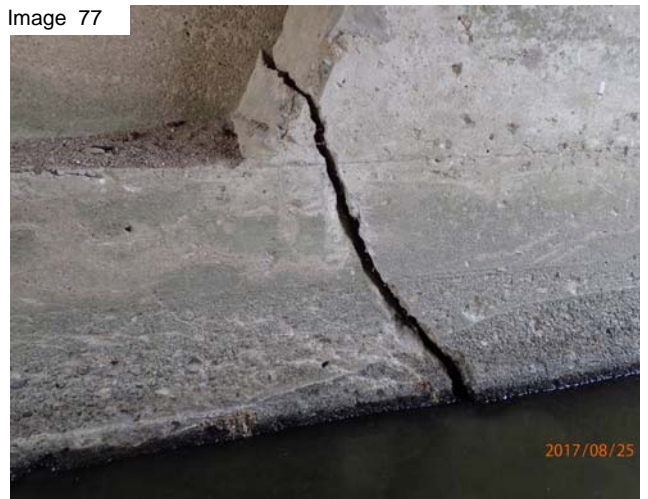
Image 77

Wide crack in the west wall

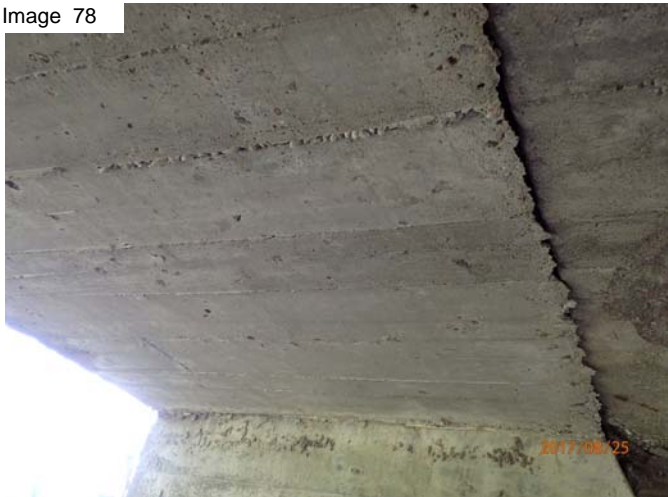
Image 78

Soffit at north extension

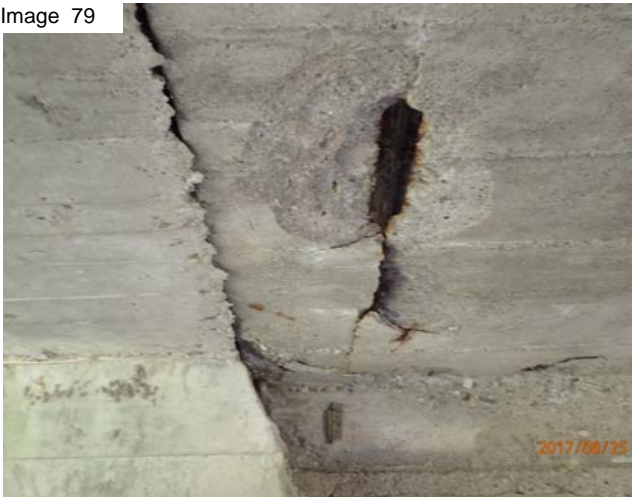
Image 79

Spall in soffit near extension

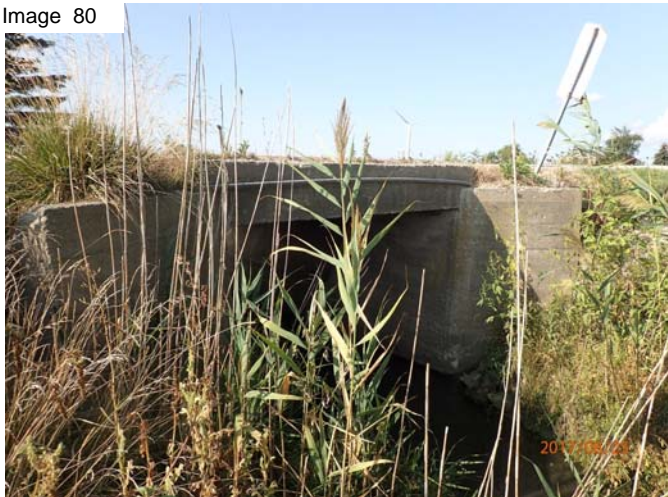
Image 80

North elevation

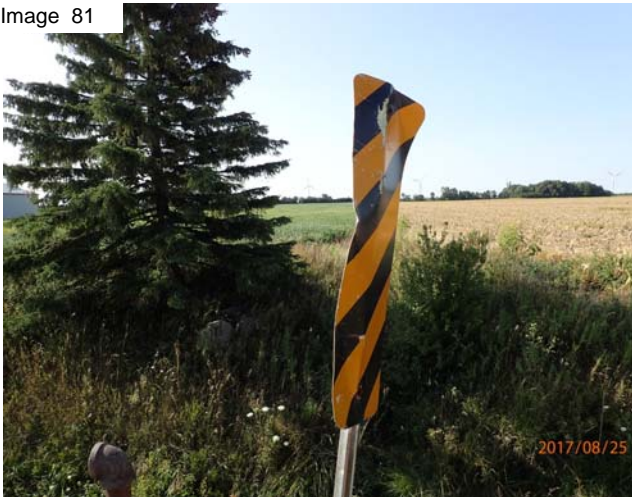
Image 81

Damaged delineator sign SW
