Culvert Inspection Report

Mill Creek Scratch Wigle Drain Culvert

Road Name: *McCallum Drive*
 Site ID: *503*
 Structure Type: *Soil-Steel Structure*
 Owner: *Town of Kingsville*
 Built: *1980*
 Length: *21.6 m*
 Width: *3.7 m*
 Spans: *1*
 Spans Arrange: *1 - 3.8*
 Feature Through *Water*
 Crossing: *Wigle Drain*
 Location: *0.1km East of Sumac Drive*

Inspection Date: *August-22-17*
 Inspector: *Steve Reid, C.E.T.*
 Assistant: *Brad Lair, Eng Student*

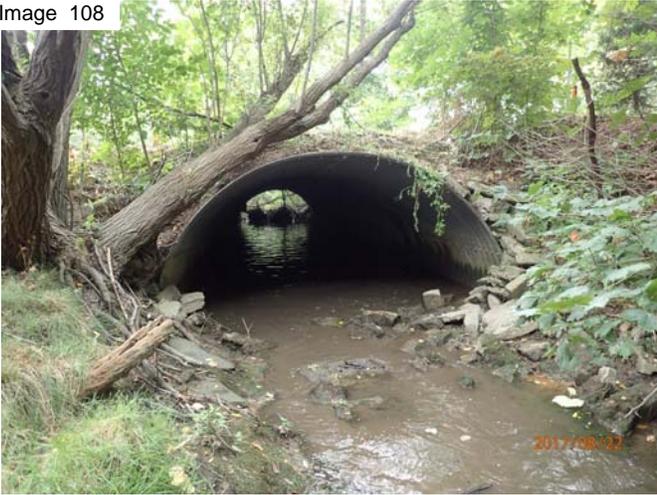
Image 108

South elevation

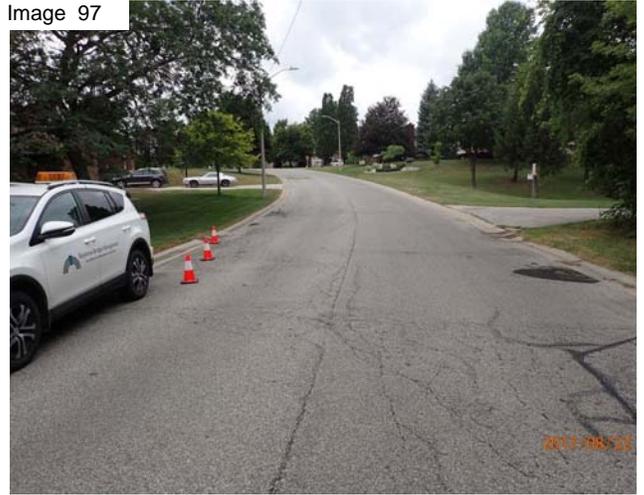
Image 97

East approach

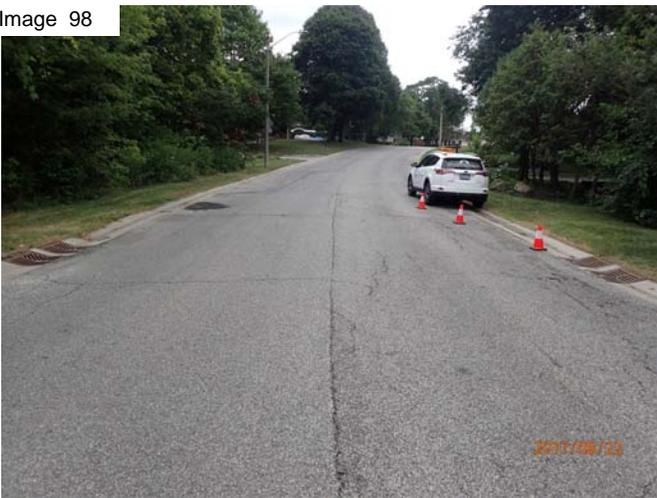
Image 98

West approach

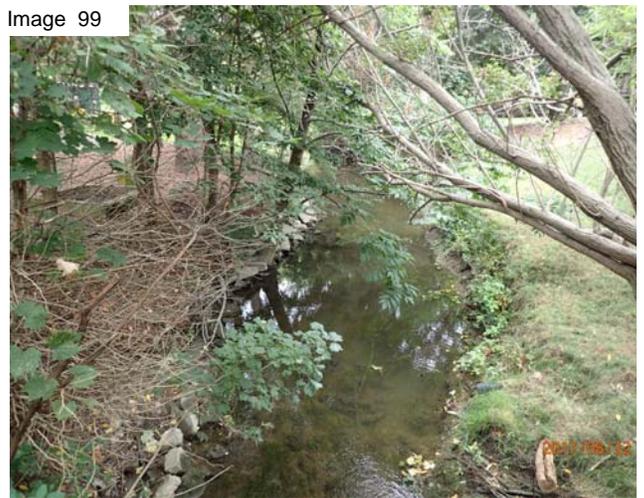
Image 99

Downstream channel south

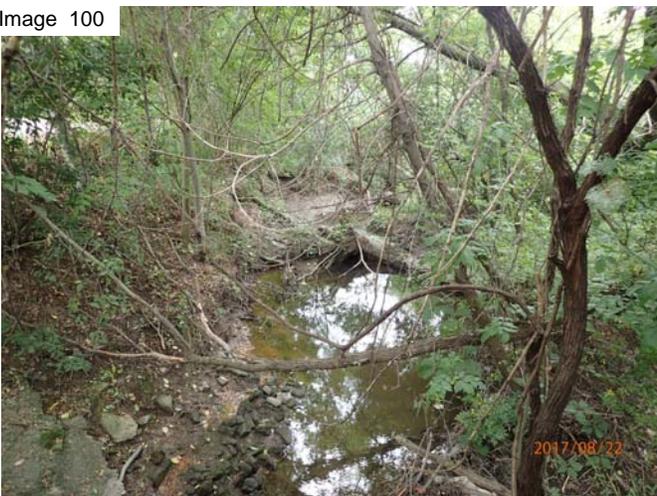
Image 100

Upstream channel north

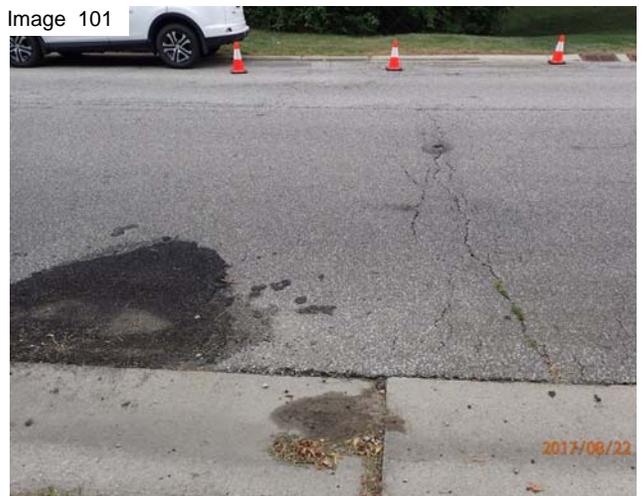
Image 101

Pothole over culvert loss of fill

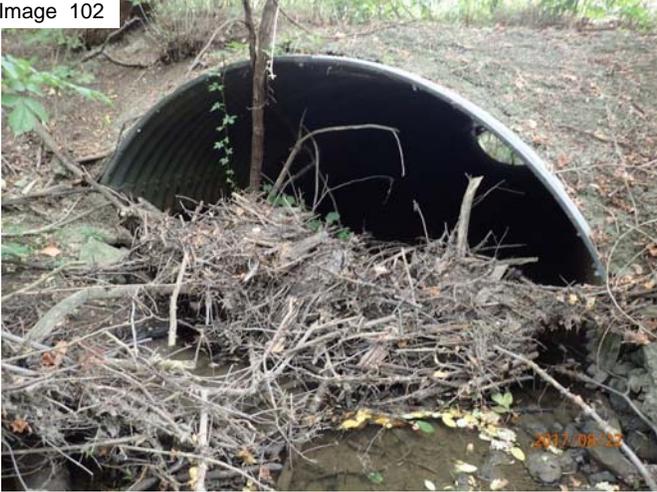
Image 102

<i>Debris partially blocking inlet north end. Culvert holding up to 500mm water inside.</i>				
Embankment (2)		Defects 0.0%		
Embankment		Damage 0.0%		
		Maintenance	None	
		Capital Rec.	None	
<i>Mass concrete at north end. Heavy vegetation growth at culvert ends.</i>

North elevation inlet

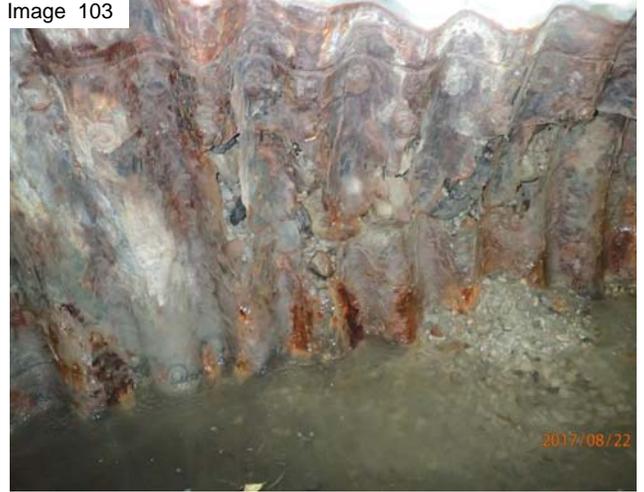
Image 103

Length:	21.6 m	Maintenance	None	
Width:	3.7 m	Capital Rec.	Replace in 1 year	Perf Def: Load Carrying Capacity
Height:	2.2 m	<i>Culvert has perforated along east wall at north end for a length of approximately 5.0m, backfill is spilling into culvert through perforated wall. West wall in similar condition at north end however not as severe. Culvert is in danger of failure under WBL.</i>		
Asphalt Wear Surf (1)		Defects 0.0%		
Wear Surface		Damage 10.0%	Moderate Cracking, Major Potholing	
Length:	20 m	Maintenance	None	
Width:	6.5 m	Capital Rec.	None	
Height:		<i>Pothole in WBL due to loss of fill through perforated culvert wall. Numerous cracks in surface.</i>		
Water Channel (1)		Defects 0.0%		
Conduit Channel		Damage 0.0%		
		Maintenance	None	
		Capital Rec.	None

Perforations east wall fill spilling in

Recommended Capital Works:
New Conc culvert

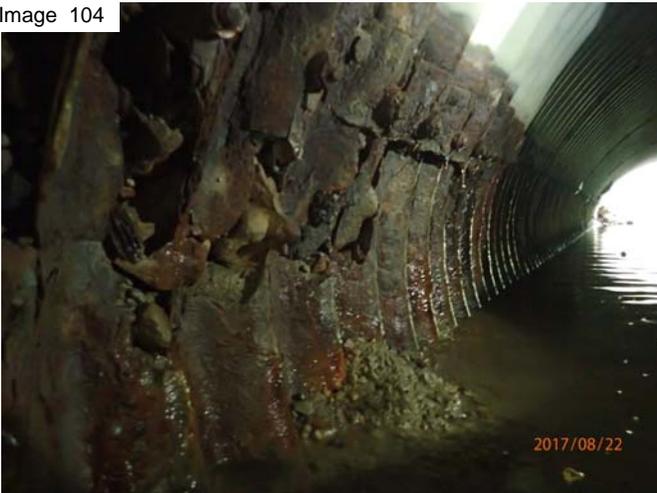
Image 104

East wall perforations along wall

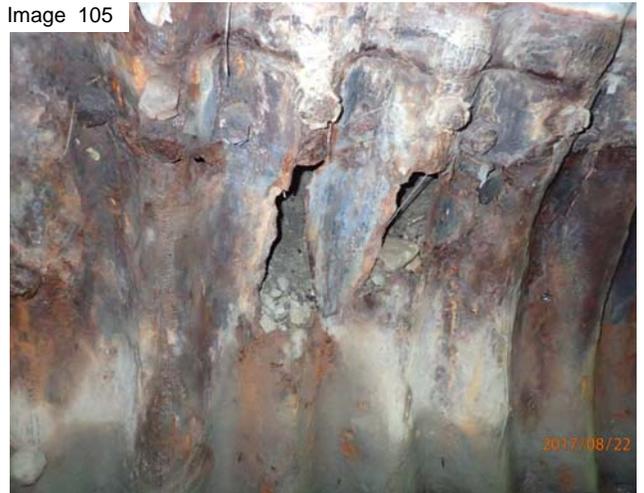
Image 105

West wall perforations

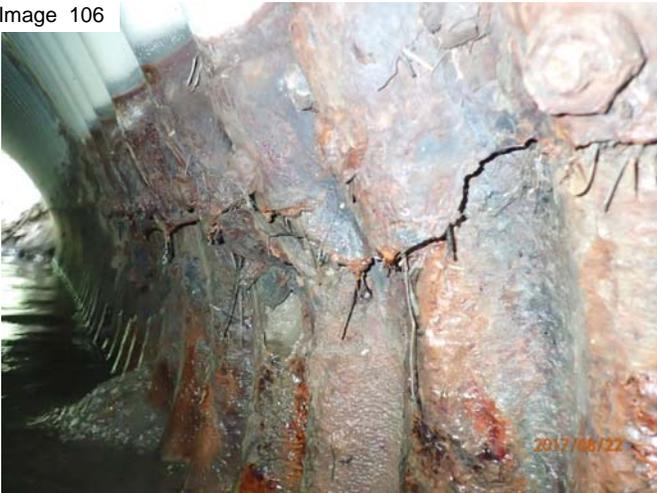
Image 106

East wall total separation along wall

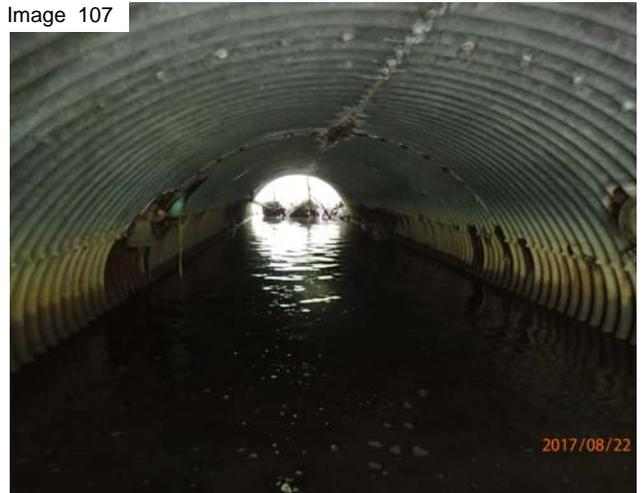
Image 107

Typ through from south
