## **Appendix A**

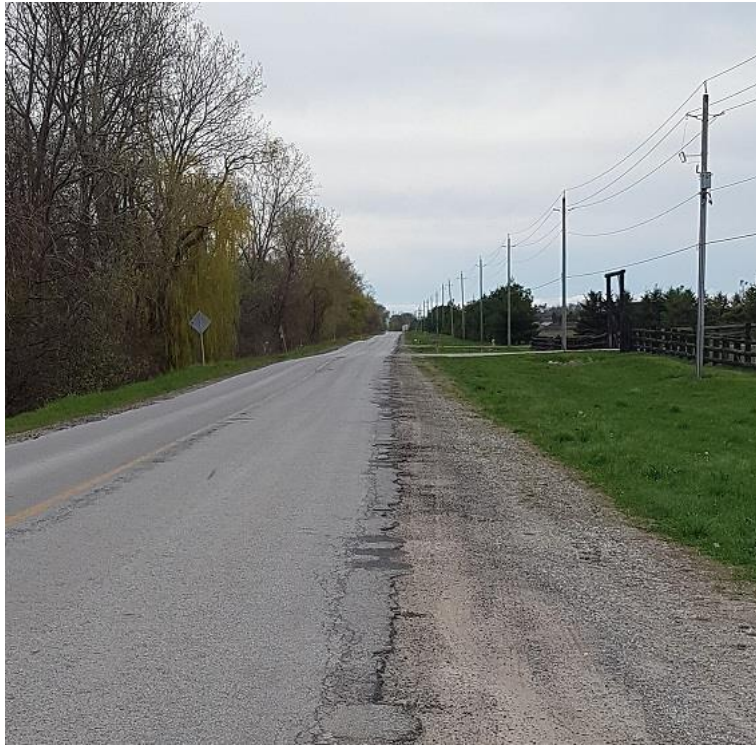
**Picture 1: Edge Line Failure**
