## MUNICIPAL STRUCTURE INSPECTION FORM

Structure ID: 050

| Structure Name | <u>Mill Creek Bridge</u> | | | | |

Date of Inspection: March 28, 2019 Type of Inspection: ☒ OSIM ☐ Enhanced OSIM  
 Inspector: Mohamed El-Sarji, P.Eng.; AUE Structural Inc.  
 Others in Party: Tova Govia, P.Eng.; AUE Structural Inc.  
 Enh. Access Equipment: None  
 Special Access Equipment: None  
 Weather: Overcast Temperature: 12 °C

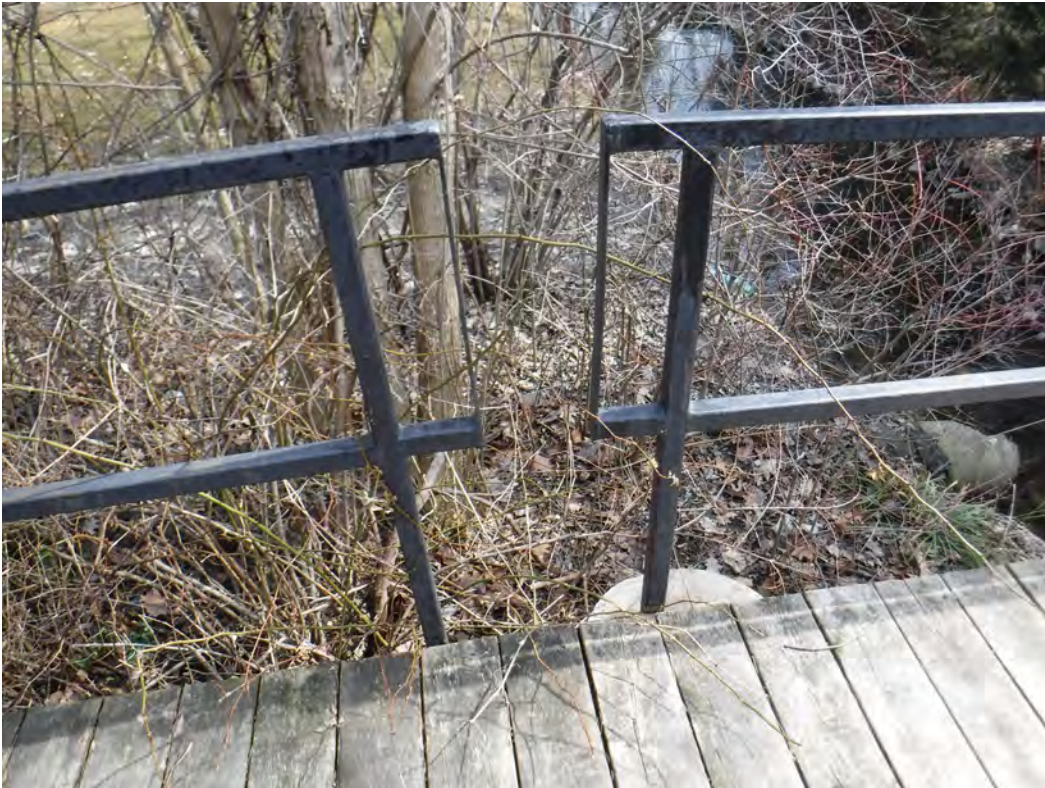
| ELEMENT DATA | | | | | |
|---|---|---|---|---|---|
| <b>Comments:</b> <ul style="list-style-type: none"> <li>Localized light corrosion noted on barrier.</li> <li>Gaps observed between steel panels.</li> <li>The existing barrier does not conform to current standards and should be replaced with a code compliant barrier within a year. A roadside safety review is recommended in order to determine barrier requirements.</li> </ul> | | | | | |

**Photo 9:** Gap between barrier panels

| ELEMENT DATA | | | | | |
|---|---|---|---|---|---|
| <b>Recommended Work:</b> <input type="checkbox"/> Rehab. <input checked="" type="checkbox"/> Replace <input checked="" type="checkbox"/> 1 – 5 Years <input type="checkbox"/> 6 – 10 Years | | | <b>Maintenance Needs:</b> <input type="checkbox"/> Urgent <input type="checkbox"/> 1 Year <input type="checkbox"/> 2 Years | | |

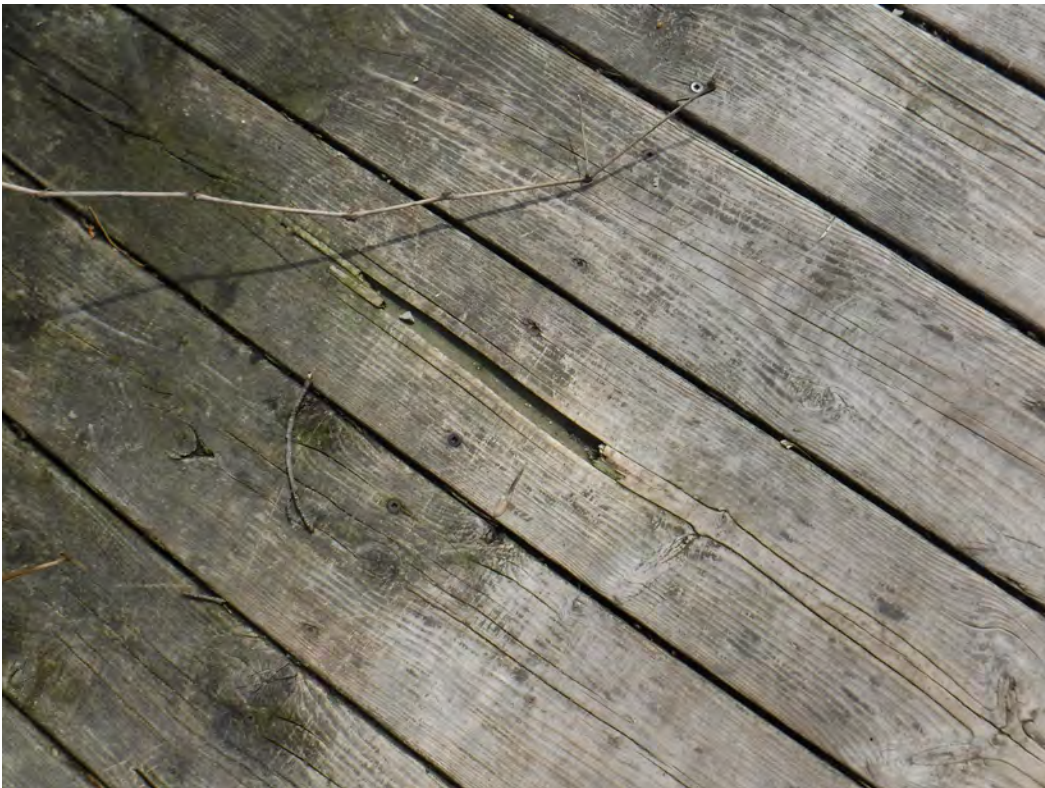
| <b>Comments:</b><br>– Light to medium checks, splits and splinters noted on timber deck.<br>– Localized missing sections also observed.<br>– Localized rot and deterioration noted on deck top.<br>– Timber planks can be replaced as required. | | | | | |

**Photo 10:** Missing piece and checks at timber deck

| Performance Deficiencies: 00 – None | | | Maintenance Needs: 09 - Timber Repair | | |

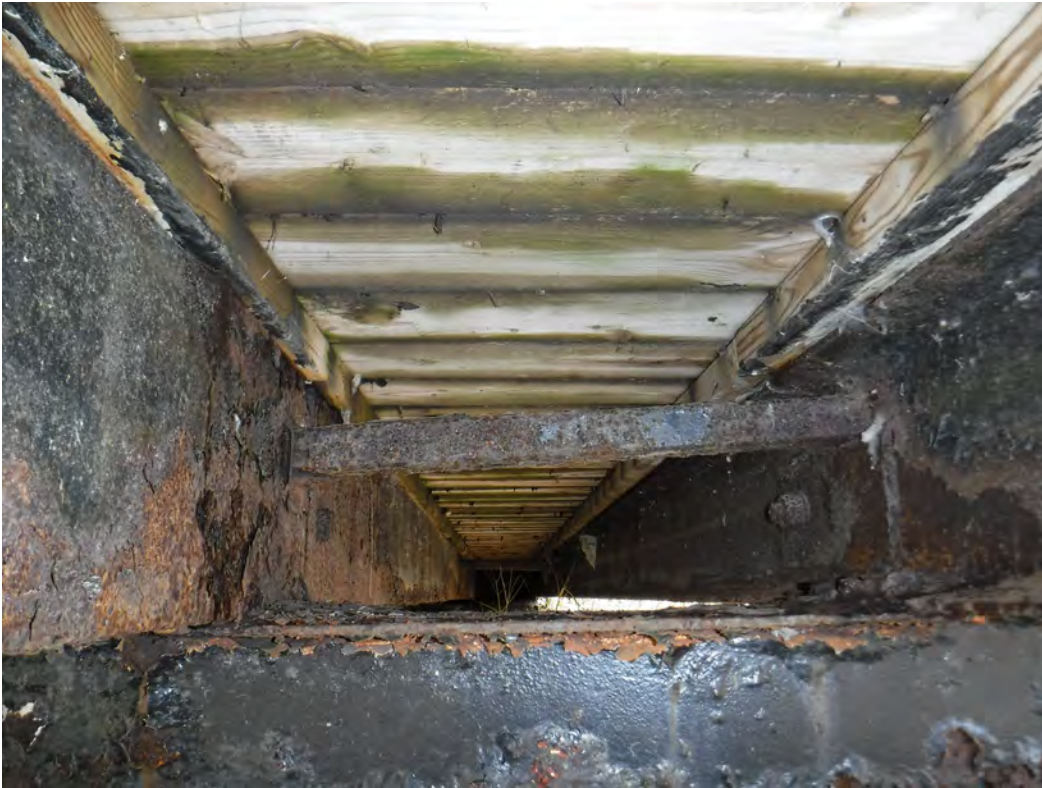
| ELEMENT DATA | | | | | |
|---|---|---|---|---|---|
| <b>Comments:</b><br>Medium to severe corrosion noted on diaphragms. | | | | | |

**Photo 13:** Typical diaphragm

| ELEMENT DATA | | | | | |
|---|---|---|---|---|---|
| <b>Recommended Work:</b><br><input type="checkbox"/> Rehab. <input checked="" type="checkbox"/> Replace<br><input checked="" type="checkbox"/> 1 – 5 Years <input type="checkbox"/> 6 – 10 Years | | | <b>Maintenance Needs:</b> <input type="checkbox"/> Urgent <input type="checkbox"/> 1 Year <input type="checkbox"/> 2 Years | | |

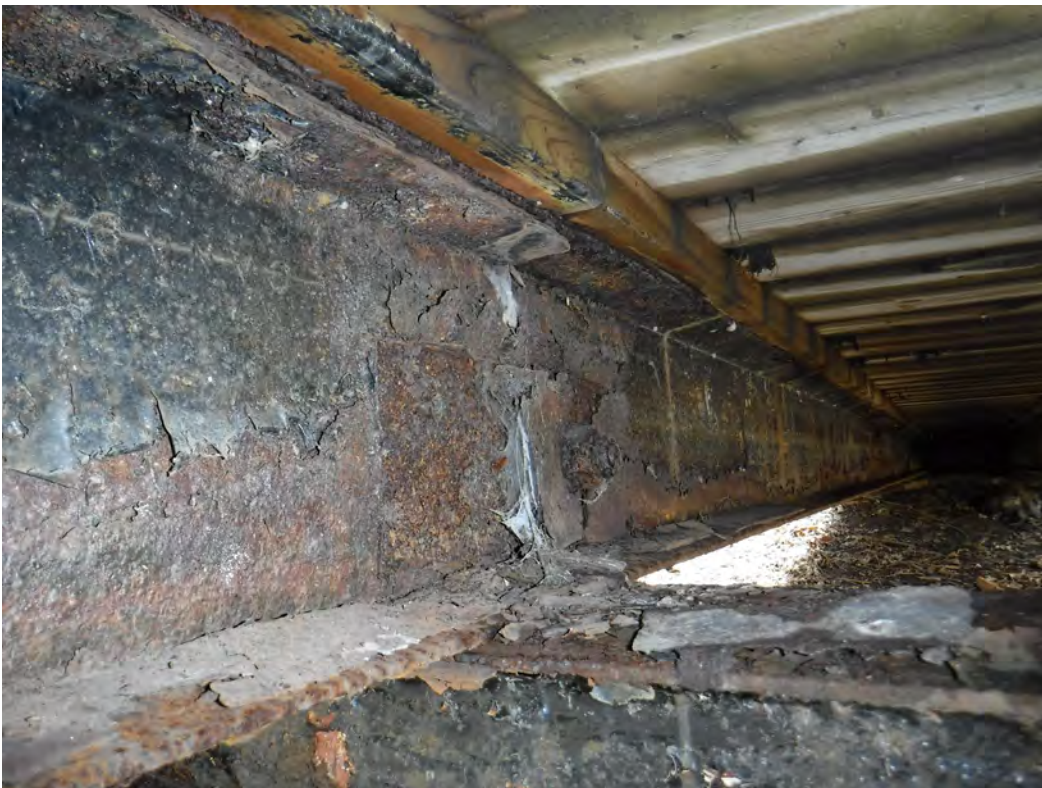
| ELEMENT DATA | | | | | |
|---|---|---|---|---|---|
| <b>Comments:</b><br>Medium to severe corrosion with flaking and section loss noted at stringers. | | | | | |

**Photo 14:** Corrosion at girder

| ELEMENT DATA | | | | | |
|---|---|---|---|---|---|
| <b>Recommended Work:</b><br><input type="checkbox"/> Rehab. <input checked="" type="checkbox"/> Replace<br><input checked="" type="checkbox"/> 1 – 5 Years <input type="checkbox"/> 6 – 10 Years | | | <b>Maintenance Needs:</b> <input type="checkbox"/> Urgent <input type="checkbox"/> 1 Year <input type="checkbox"/> 2 Years | | |

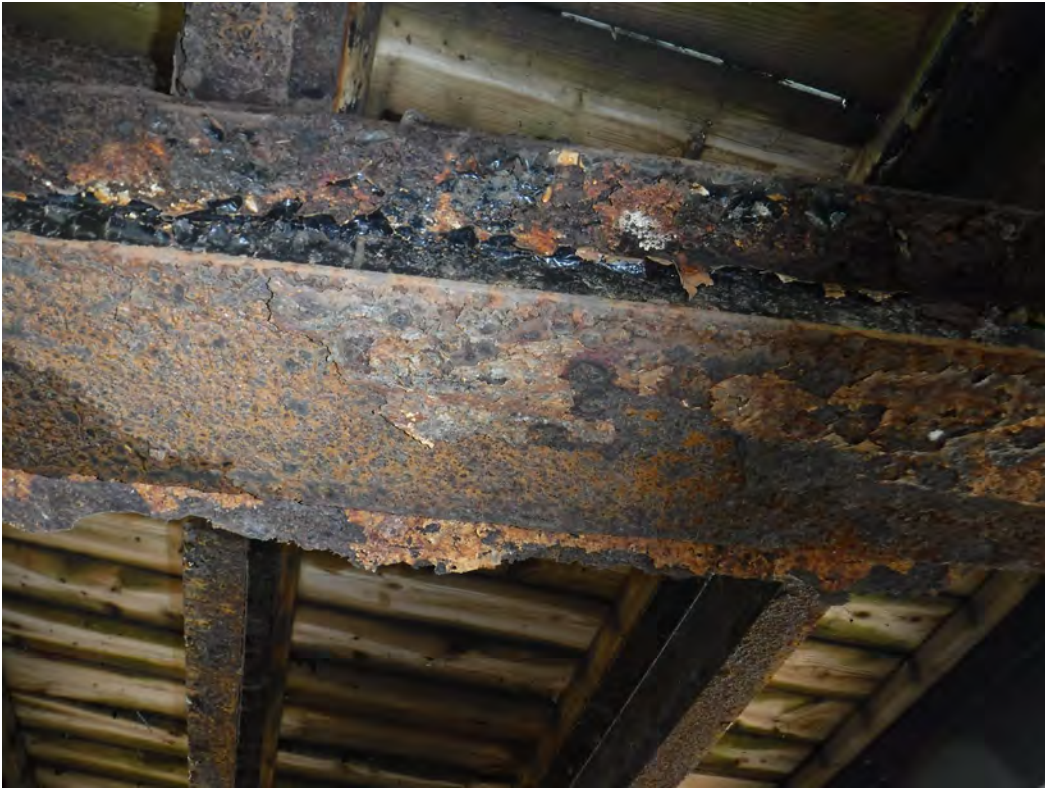
| <b>Comments:</b><br>Medium to severe corrosion with flaking and section loss noted at floor beams. | | | | | |

Photo 15: Corrosion at floor beam

| <b>Recommended Work:</b><br><input type="checkbox"/> Rehab. <input checked="" type="checkbox"/> Replace<br><input checked="" type="checkbox"/> 1 – 5 Years <input type="checkbox"/> 6 – 10 Years | | | <b>Maintenance Needs:</b> <input type="checkbox"/> Urgent <input type="checkbox"/> 1 Year <input type="checkbox"/> 2 Years | | |

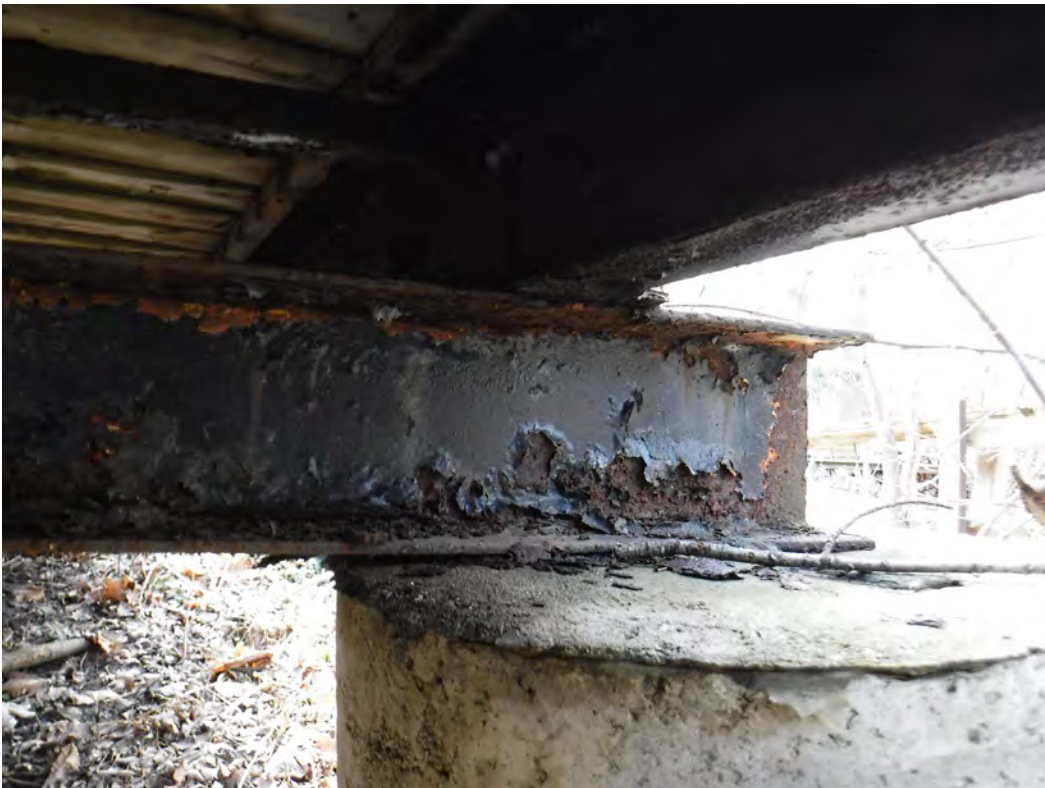
Photo 16: Corrosion at floor beam

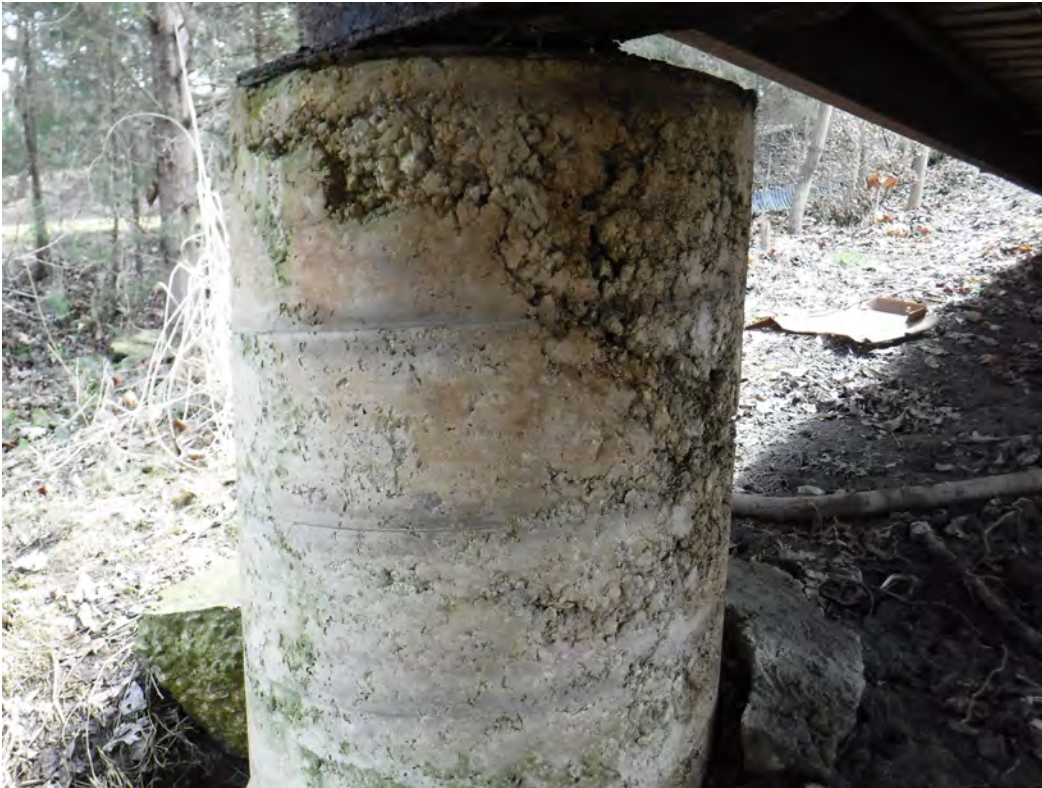
| <b>Comments:</b><br>Light to medium honeycombing noted at pier columns. | | | | | |

**Photo 17:** Honeycombing at pier column

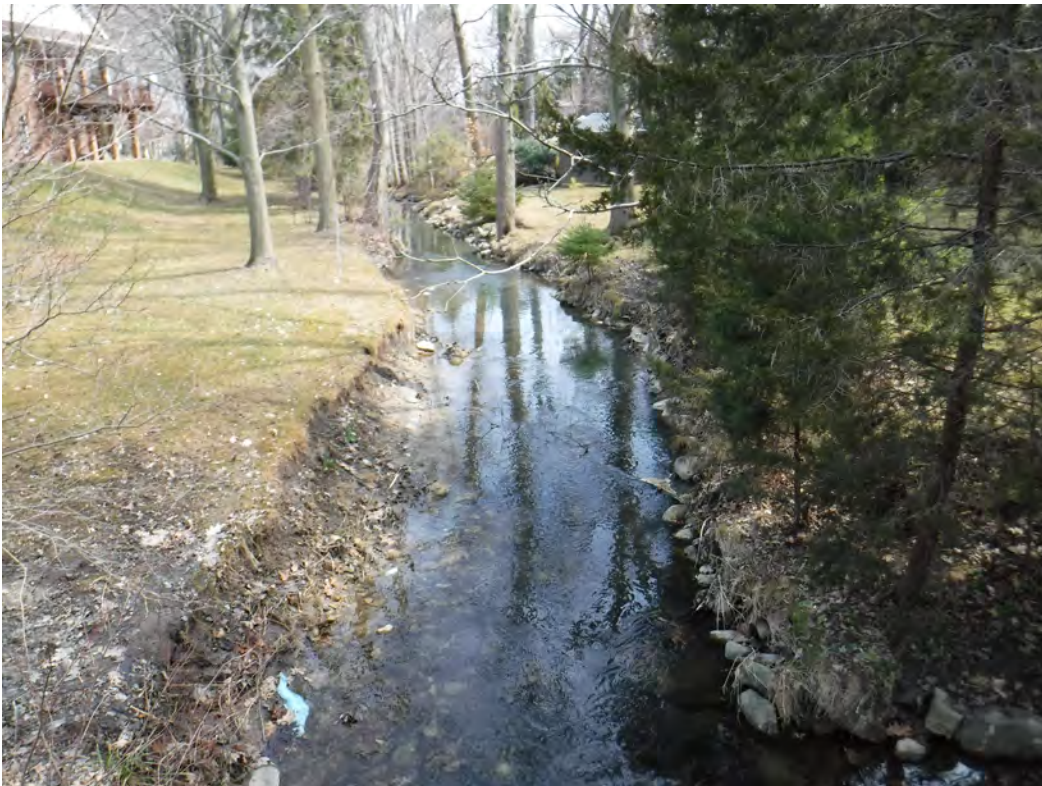
| <b>Comments:</b><br>Low volume, medium flow from east to west with scour observed upstream and downstream at the time of inspection. | | | | | |

**Photo 18:** Stream facing east

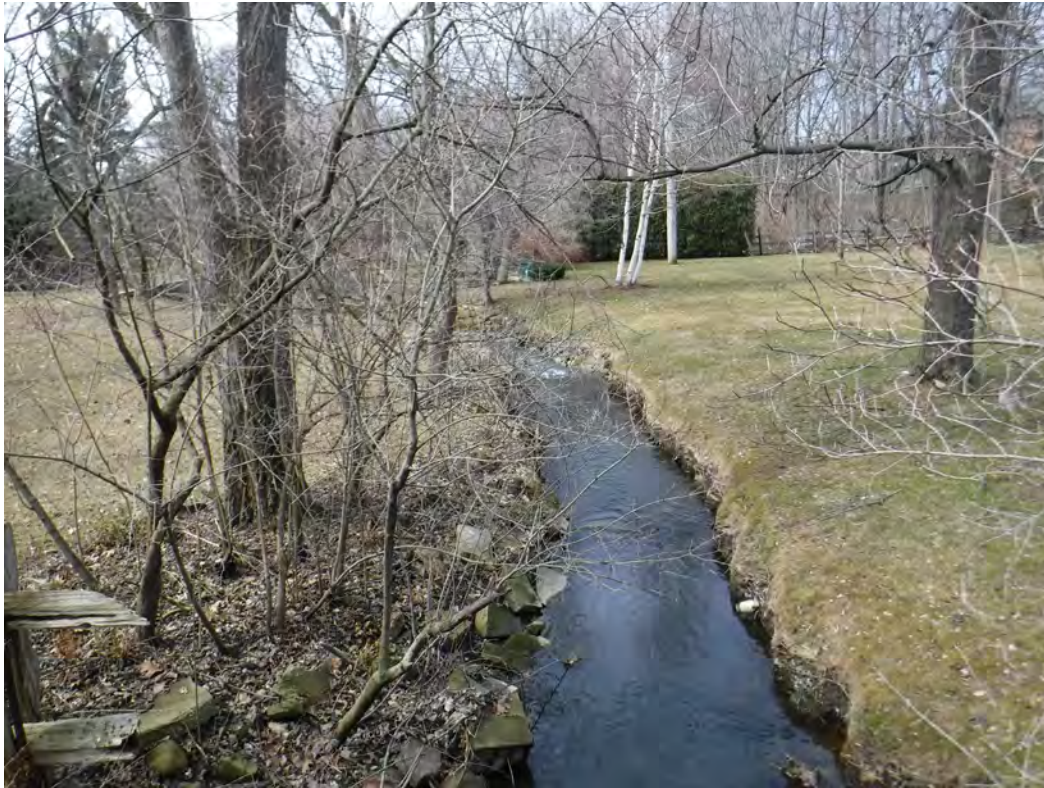
**Photo 19:** Stream facing west
