**SPECIAL MEETING OF COUNCIL
AGENDA**

ENGINEER'S REPORT CONSIDERATION--Esseltine Drain, Town of Kingsville
L. Zarlenga, P. Eng. and K. Vegh, Drainage Superintendent.

For the: Repair & Improvement of the Esseltine Drain

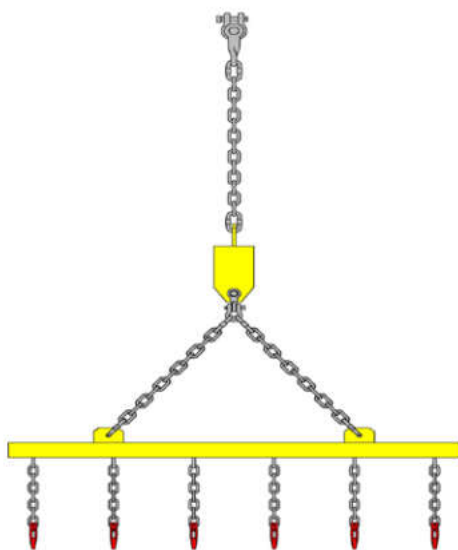
It is very important to thoroughly inspect the Lifting Bar prior to lifting any loads. The diagram below indicates what areas should be checked and noted.

8' Lifting Bar complete with 6 lifting points

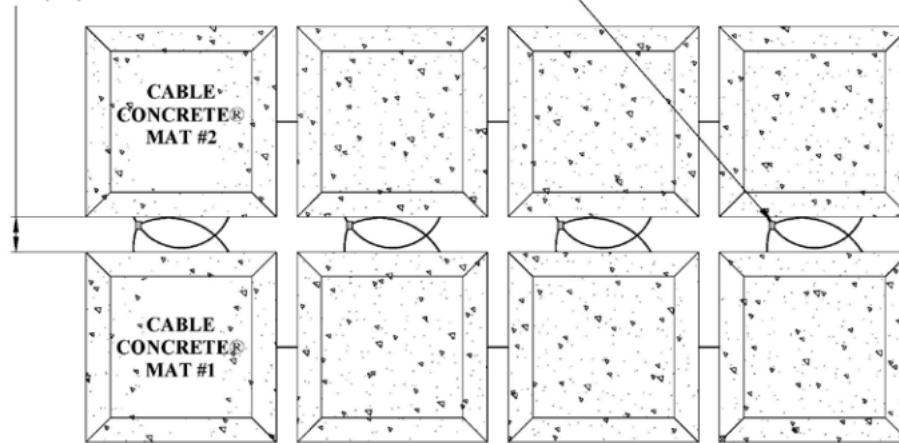
50mm(2") MAX. GAP

WHEN PLACING THE MATS, THE GAP BETWEEN THE MATS SHOULD NOT BE ANY LARGER THAN A 50mm (2") MAXIMUM. IF THE MATS ARE PLACED WITH A LARGER SPACE THAN 50mm (2"), IT IS RECOMMENDED TO GROUT THE SEAM BETWEEN THE MATS.

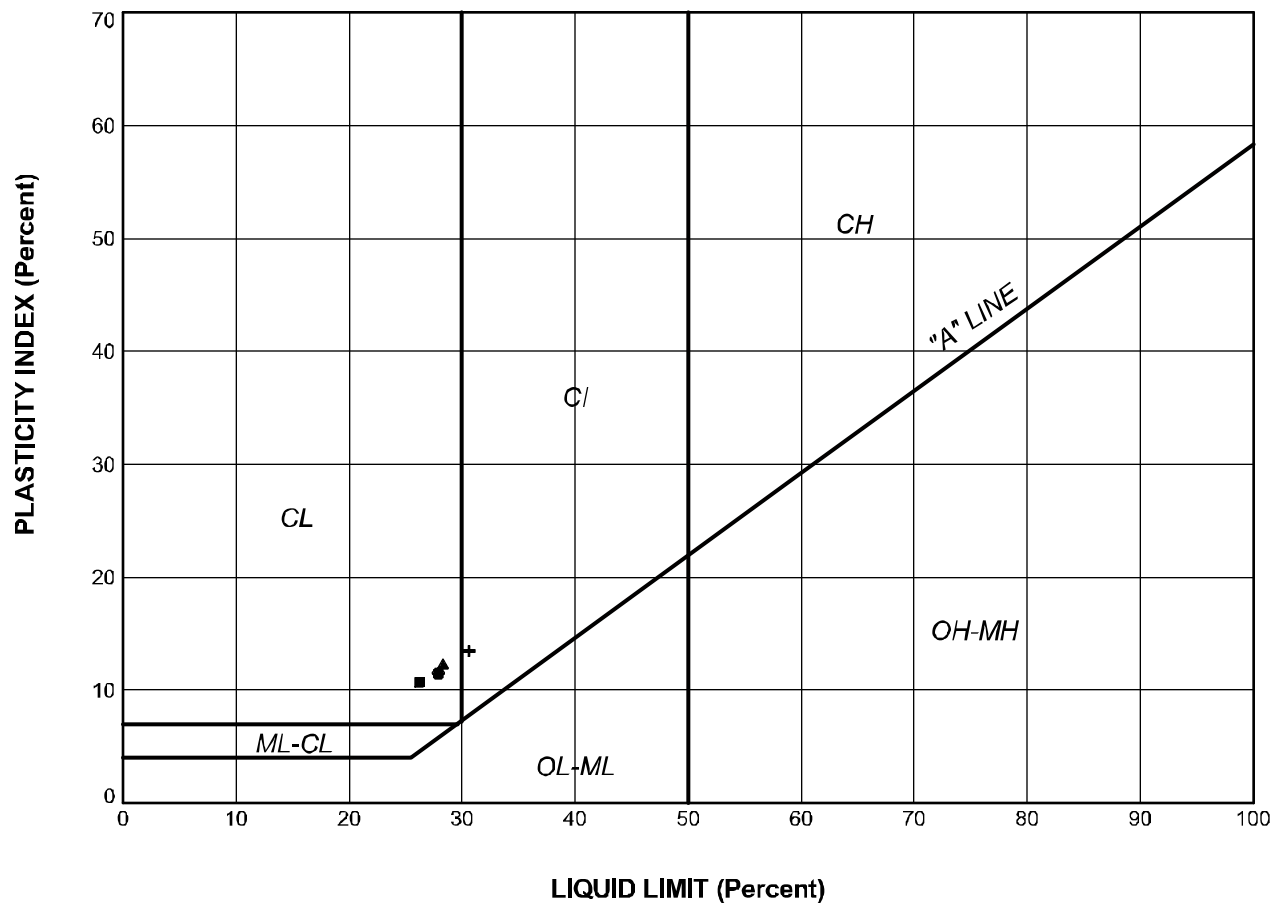
PROJECT GEOTECHNICAL INVESTIGATION ESSELTINE DRAIN IMPROVEMENTS TOWN OF KINGSVILLE, ONTARIO					
TITLE PLASTICITY CHART					
		PROJECT No. 1417810		FILE No. 22-7810-2000-R01008	
DRAWN CHECK	VDI July 03, 15	SCALE N/A		REV.	
FIGURE 8

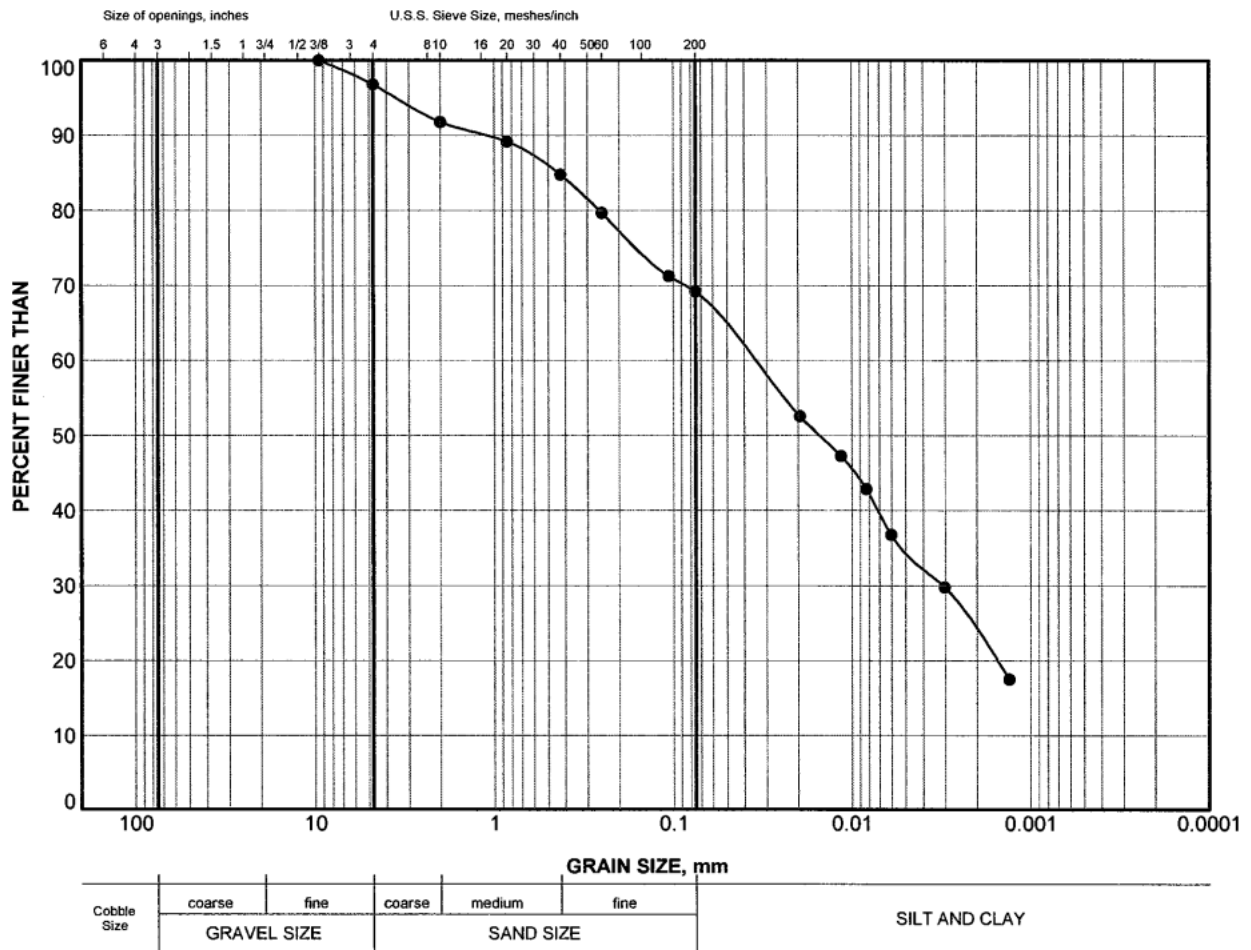
PROJECT				STANTEC CONSULTING LTD.			
				PROPOSED 2nd CONCESSION TRUNK WATERMAIN, UNION WATER SYSTEM, TOWN OF KINGVILLE, ONT.			
TITLE				GRAIN SIZE DISTRIBUTION CURVE SILTY CLAY TO CLAYEY SILT (TILL)			
PROJECT No.		011-4228		FILE No.		011-4228.GPJ	
DRAWN		T.M.		SCALE		N/A	
CHECK		12-13-01		REV.			
Golder Associates		WINDSOR, ONTARIO		FIGURE		4

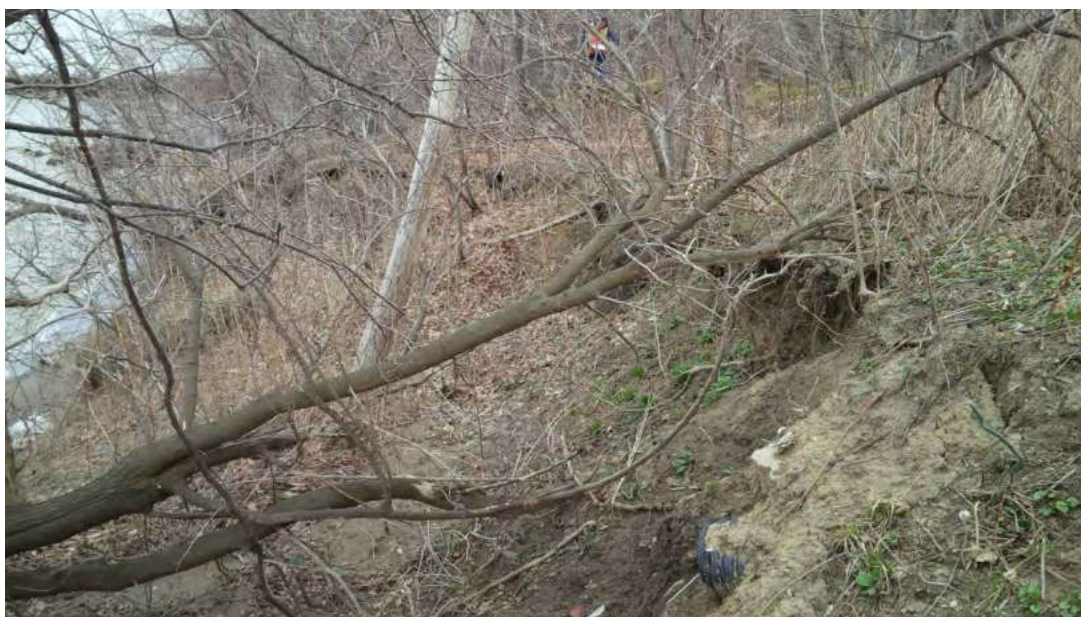
Photograph 2: Station 0+000, Section A. East slope looking west. Note previous failure zone at crest of lake bluff.

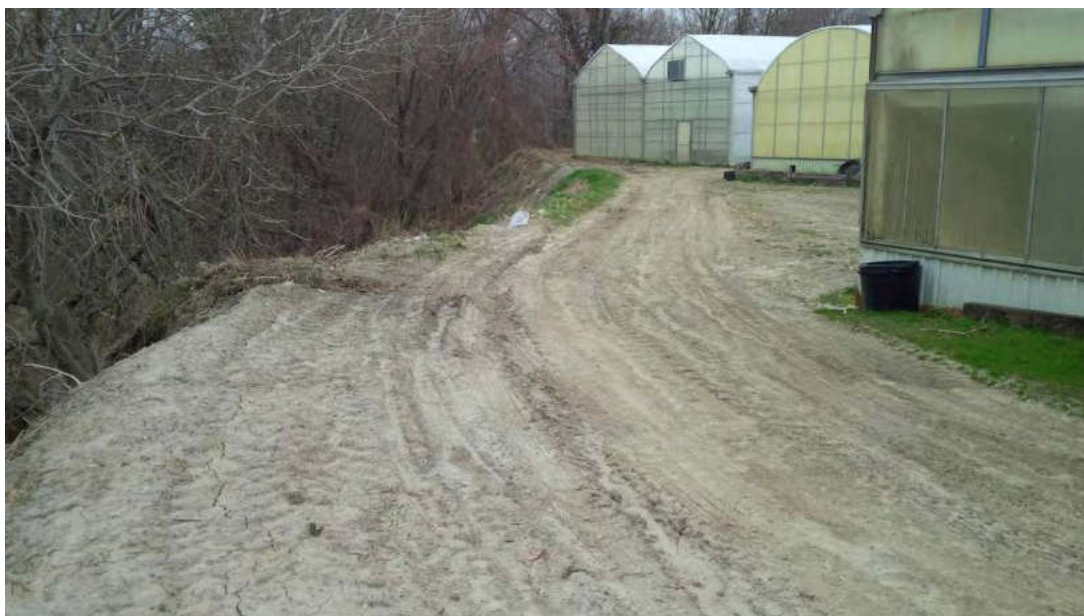
Photograph 5: Station 0+100, Section B. East slope looking upstream. Note tension cracks along crest.

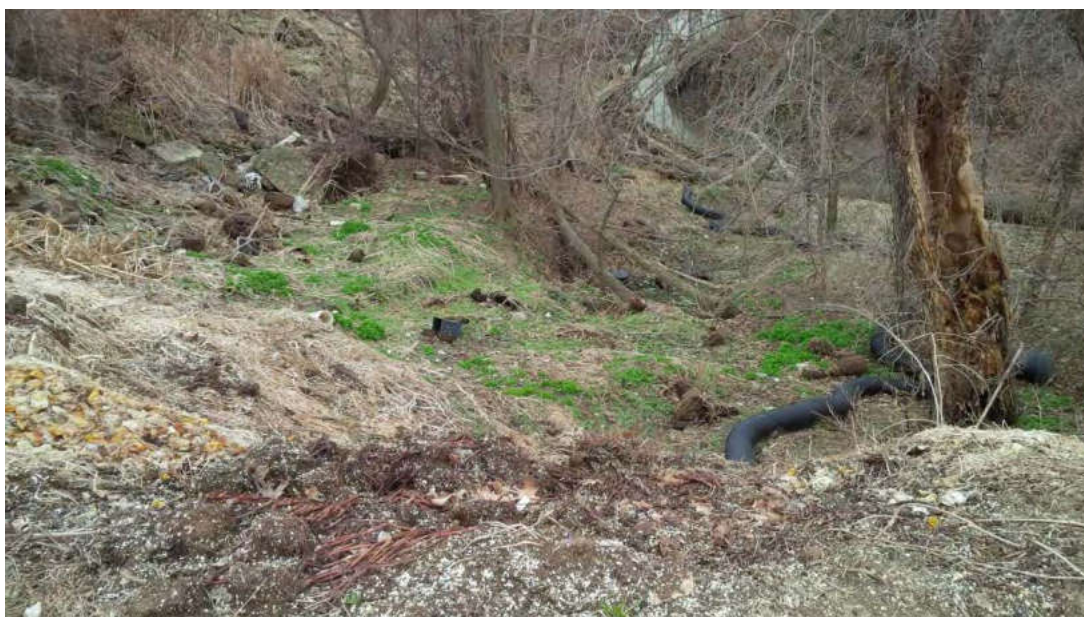
Photograph 6: Station 0+100, Section B. East slope looking downslope. Note previous dumping and storm drains.

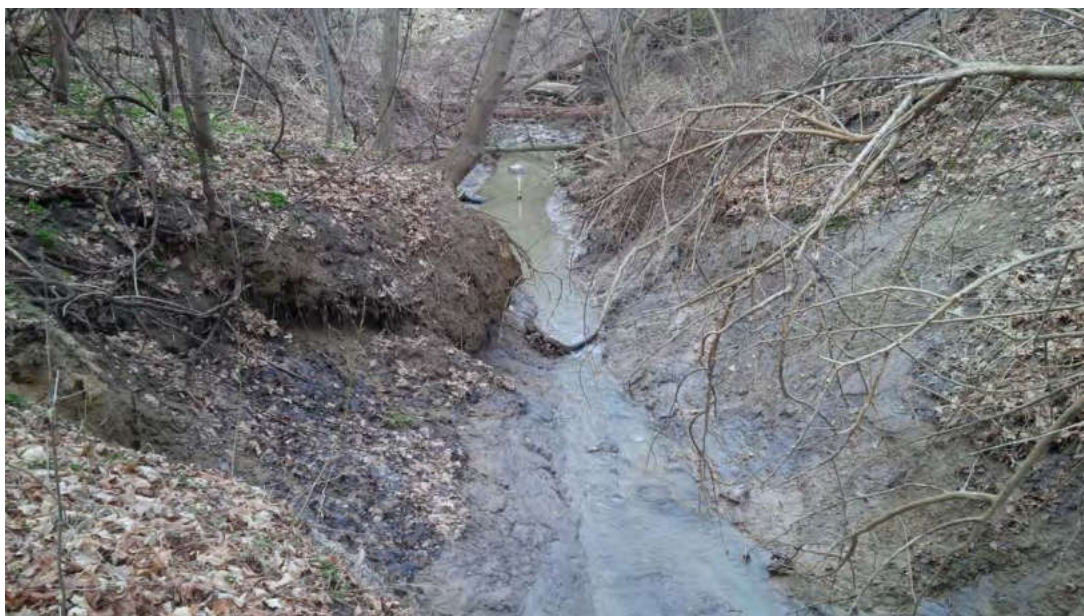
Photograph 7: Station 0+100, Section B looking downstream. Note failure zones and seepage from banks.

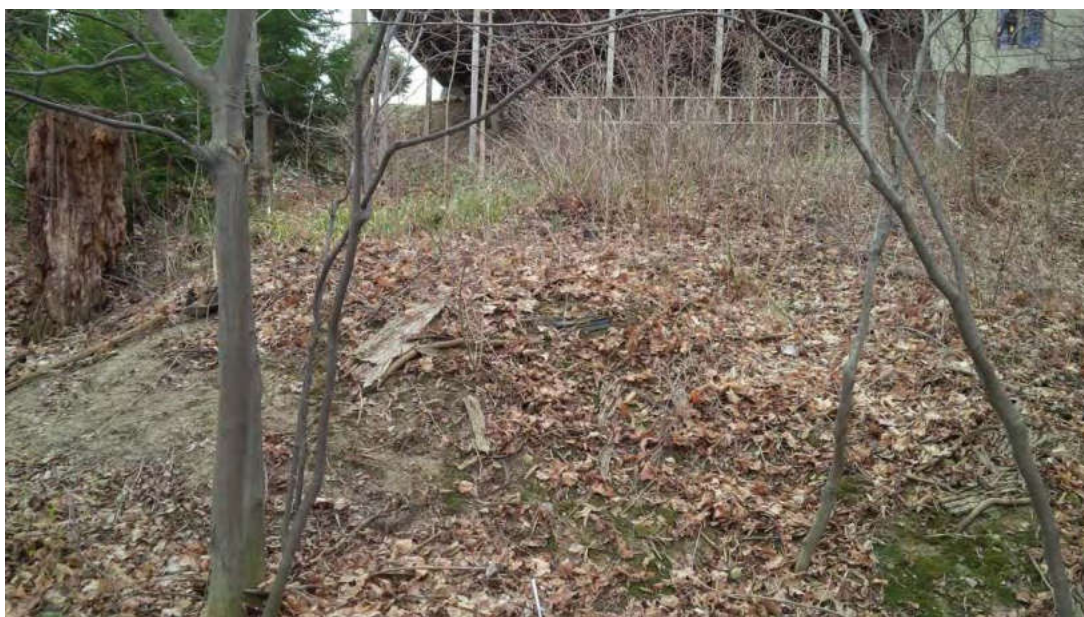
Photograph 8: Station 0+100, Section B. West slope looking upslope. Note residence near top of slope.

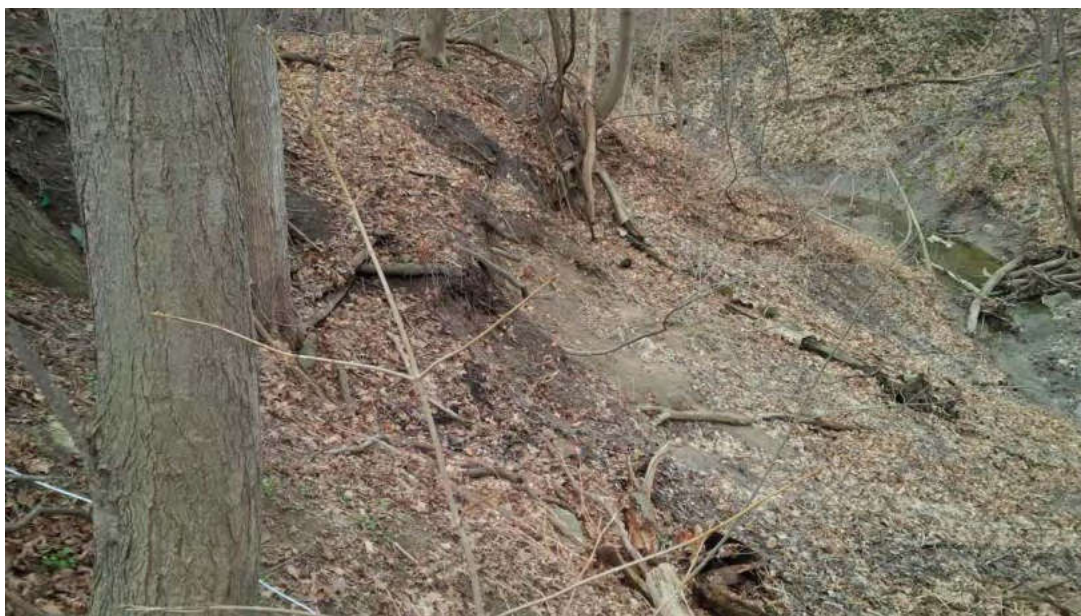
Photograph 9: Station 0+200, Section C. East slope looking downstream. Note large failure zone at lower portion of slope.

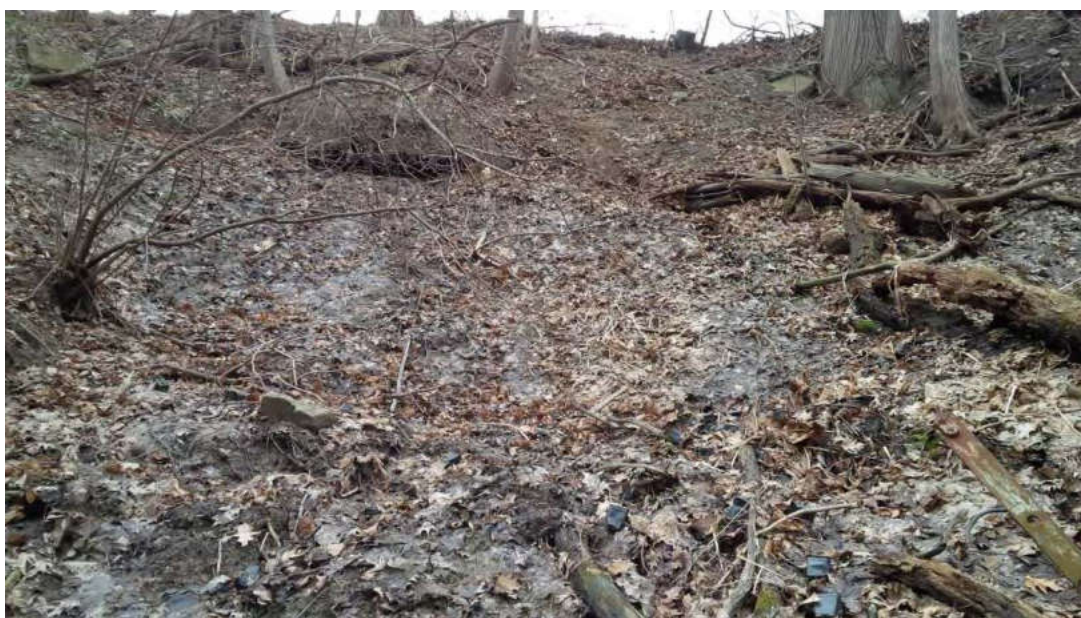
Photograph 10: Station 0+200, Section C. East slope looking upslope. Note seepage and wet sloughed material from about mid-slope.

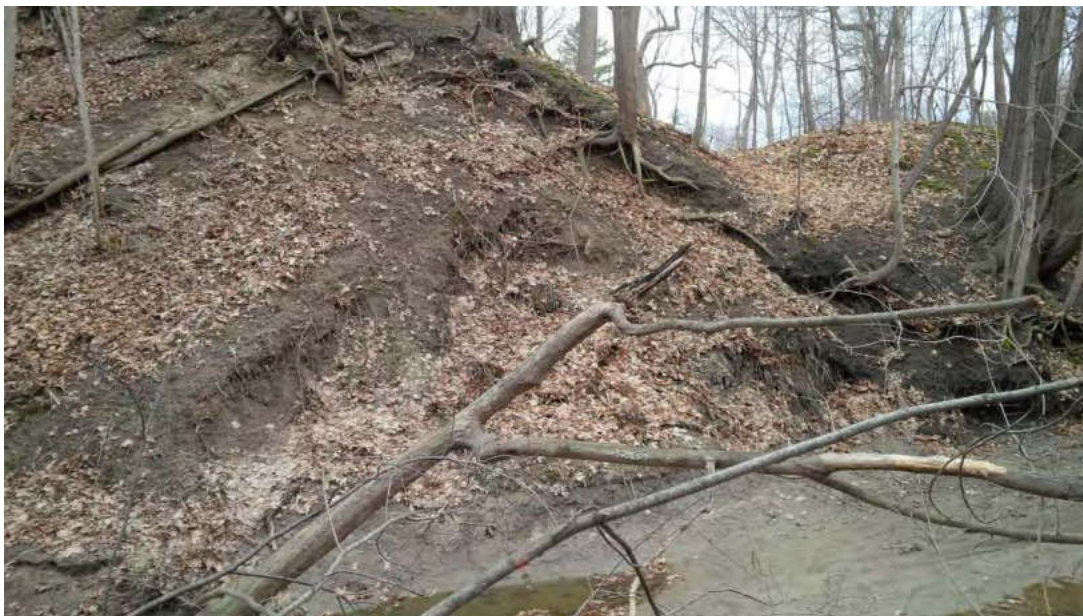
Photograph 11: Station 0+200, Section C. West slope looking upslope. Note toe erosion and failed zone within west bank.

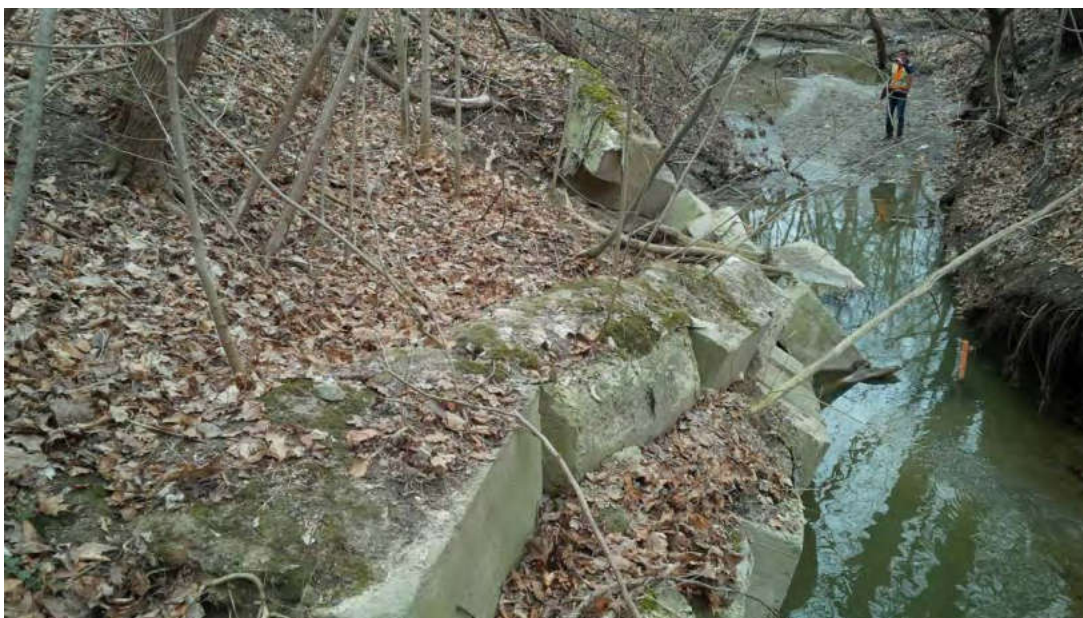
Photograph 12: Station 0+215. Looking downstream at east bank. Note failed concrete block retaining wall.

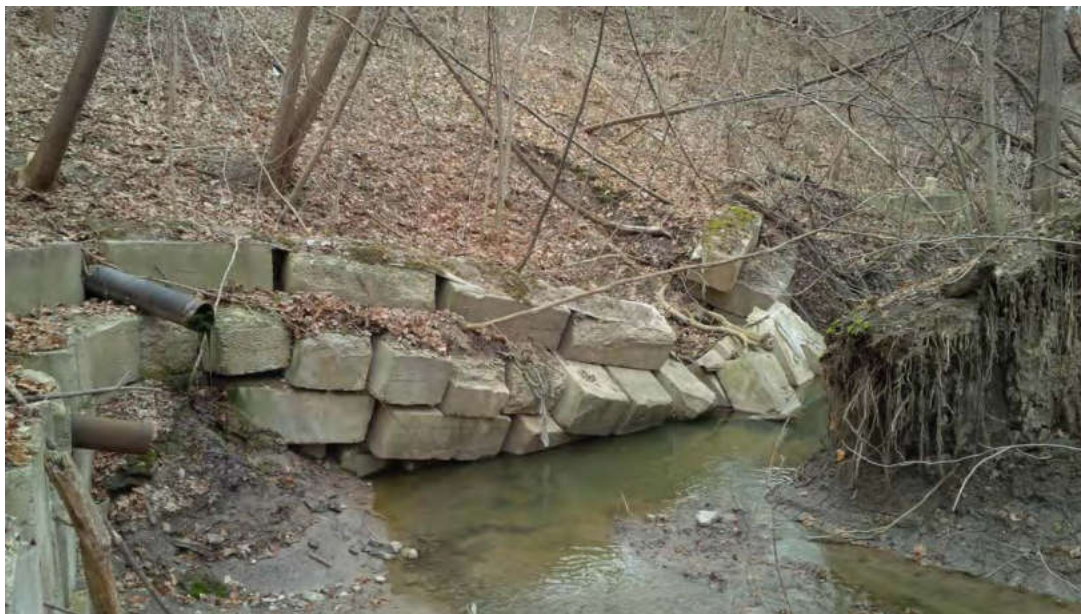
Photograph 13: Station 0+215. Looking downstream at east bank. Note concrete block retaining wall failure due to toe erosion and scouring along outside bend in drain.

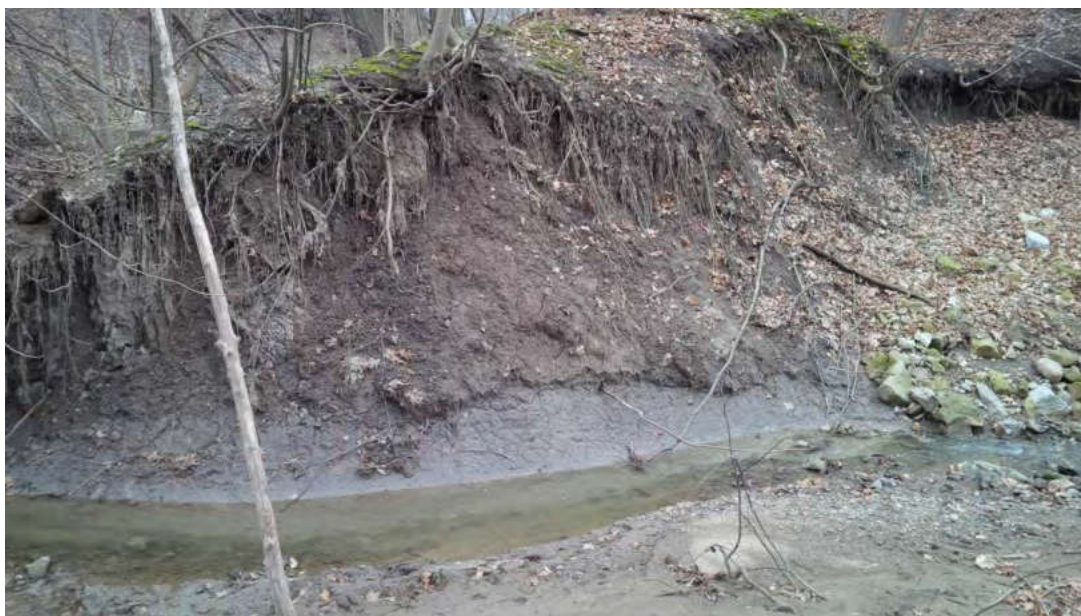
Photograph 14: Station 0+235. West bank looking west. Note erosion effects exposing silty clay.

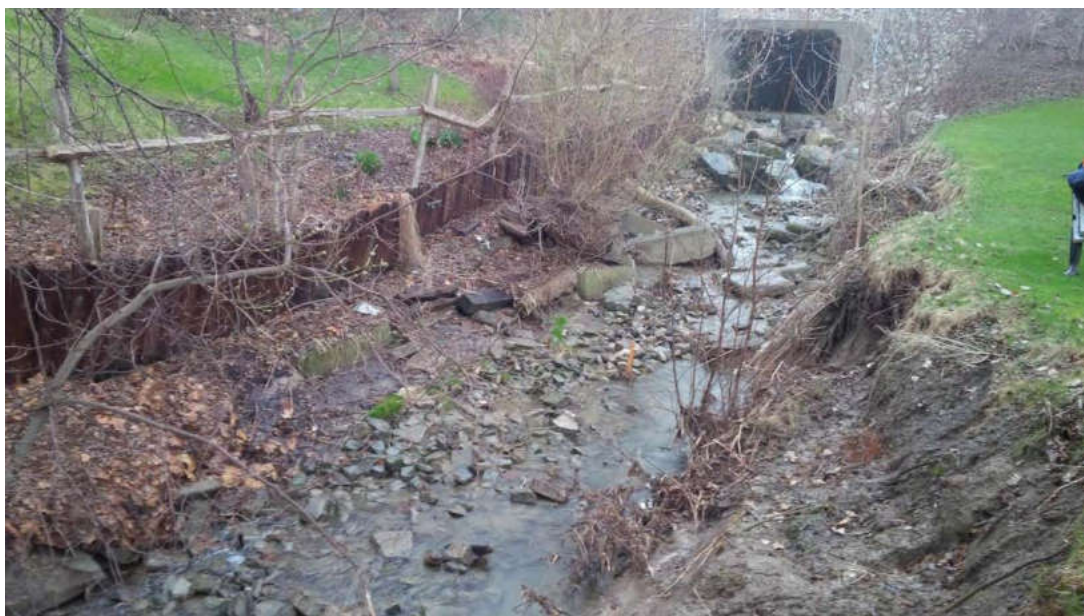
Photograph 19: Station 0+500 looking upstream. Note east bank failure and steel sheet pile wall along west bank.

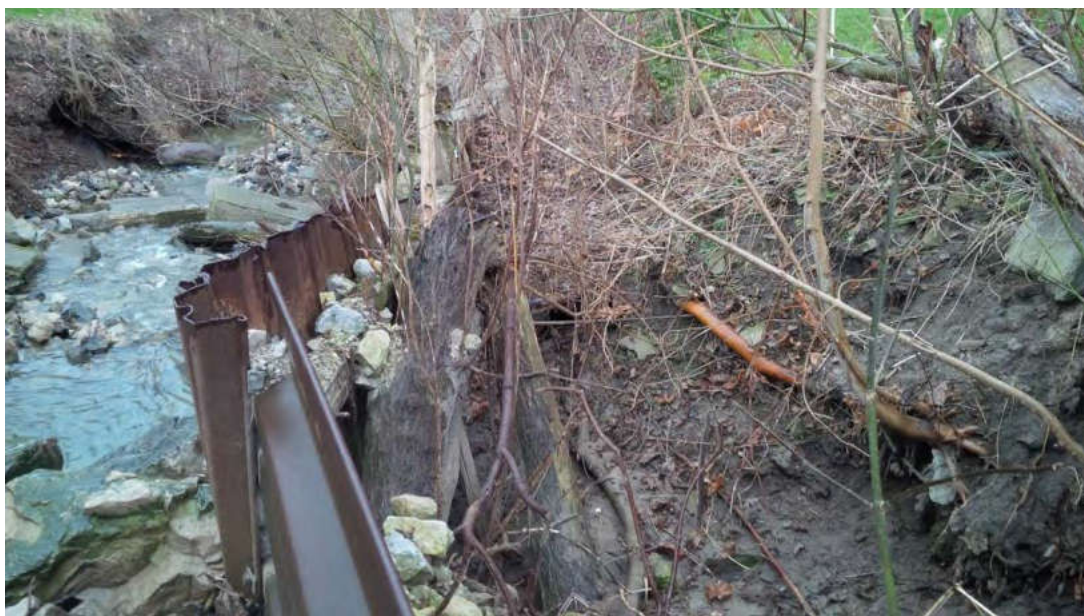
Photograph 20: Station 0+515 looking downstream. Note inward movement of steel sheet pile wall along west bank.

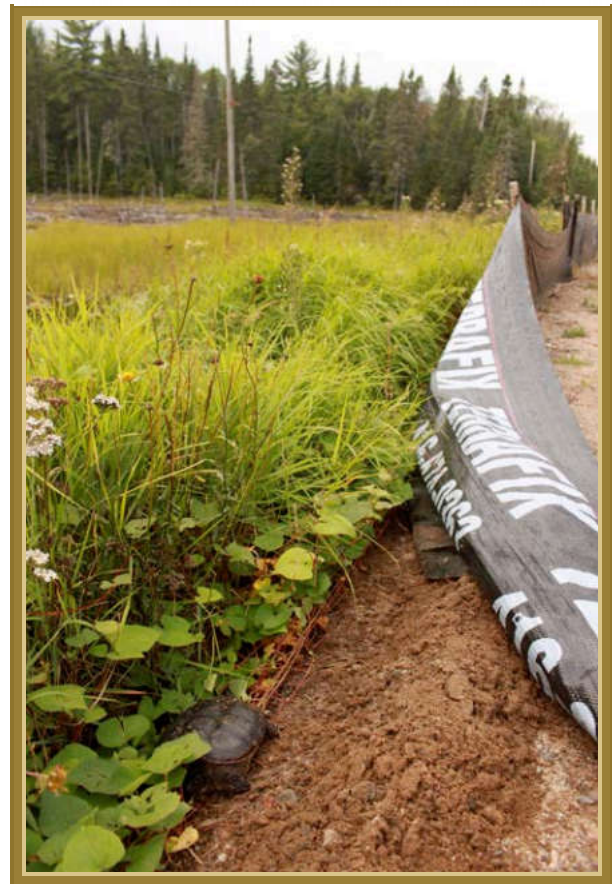
Plate 1. Light-duty geotextile fencing with pre-attached wooden stakes used to exclude turtles from a road as seen on a regular maintenance check (photo credit: Brad Steinberg).

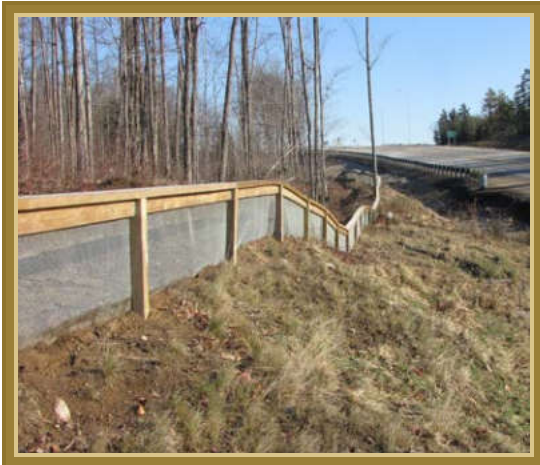
Plate 3. Example of a galvanized mesh fencing used for the long-term exclusion of snakes and turtles from the adjacent highway (photo credit: Megan Bonenfant).

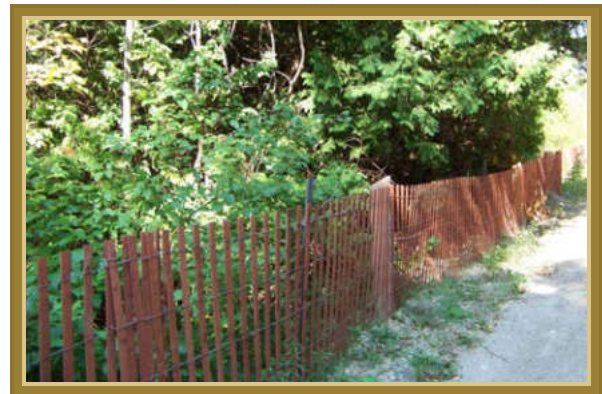
Plate 5. Example of a wood lath snow fencing used to exclude turtles (photo credit: Karine Beriault).

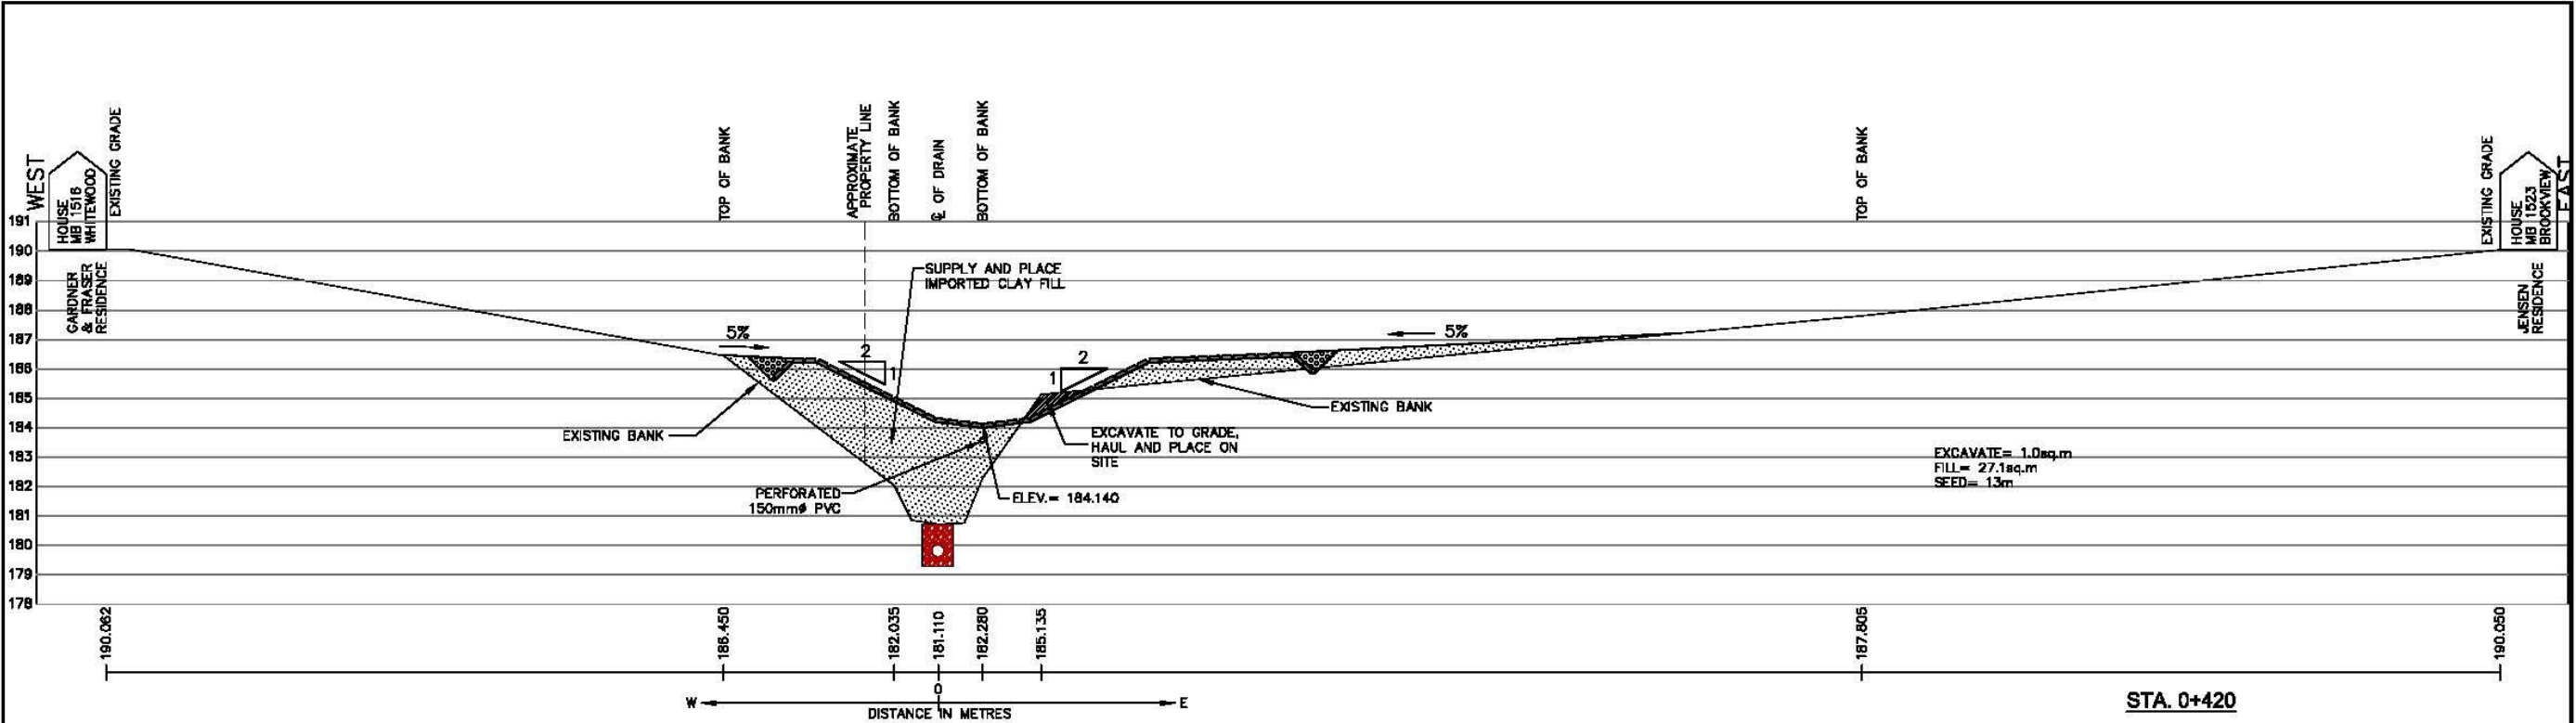
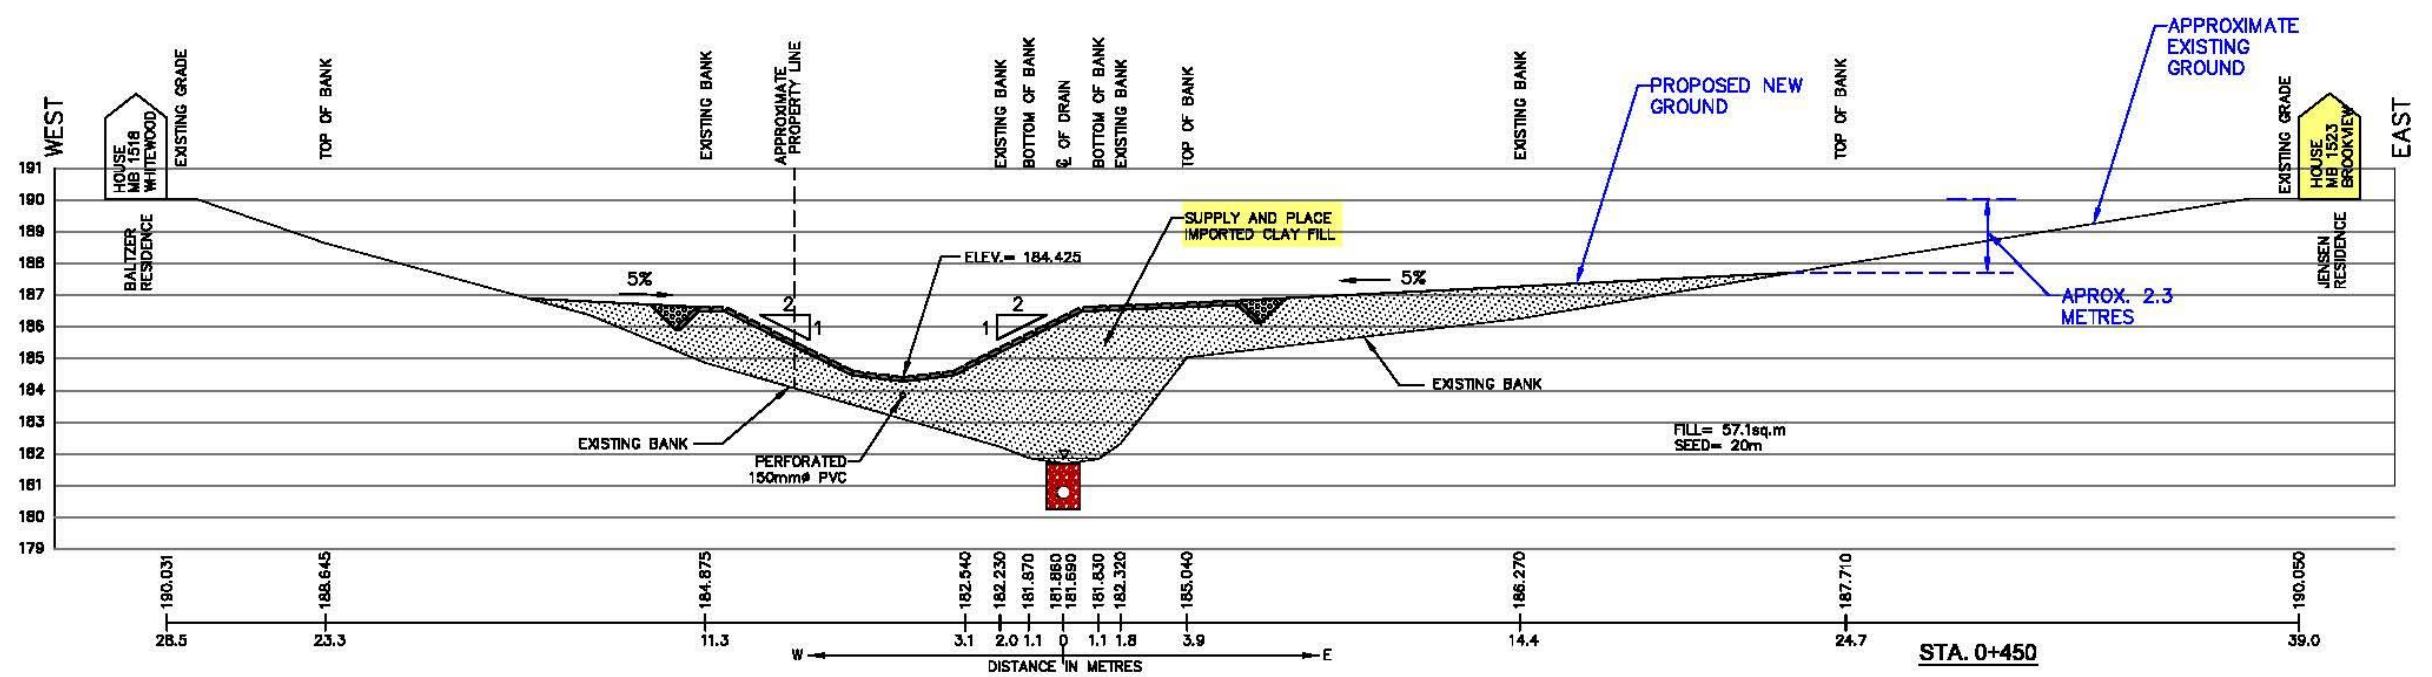
Figure 4: Jim Jensen – Ravine Cross Section

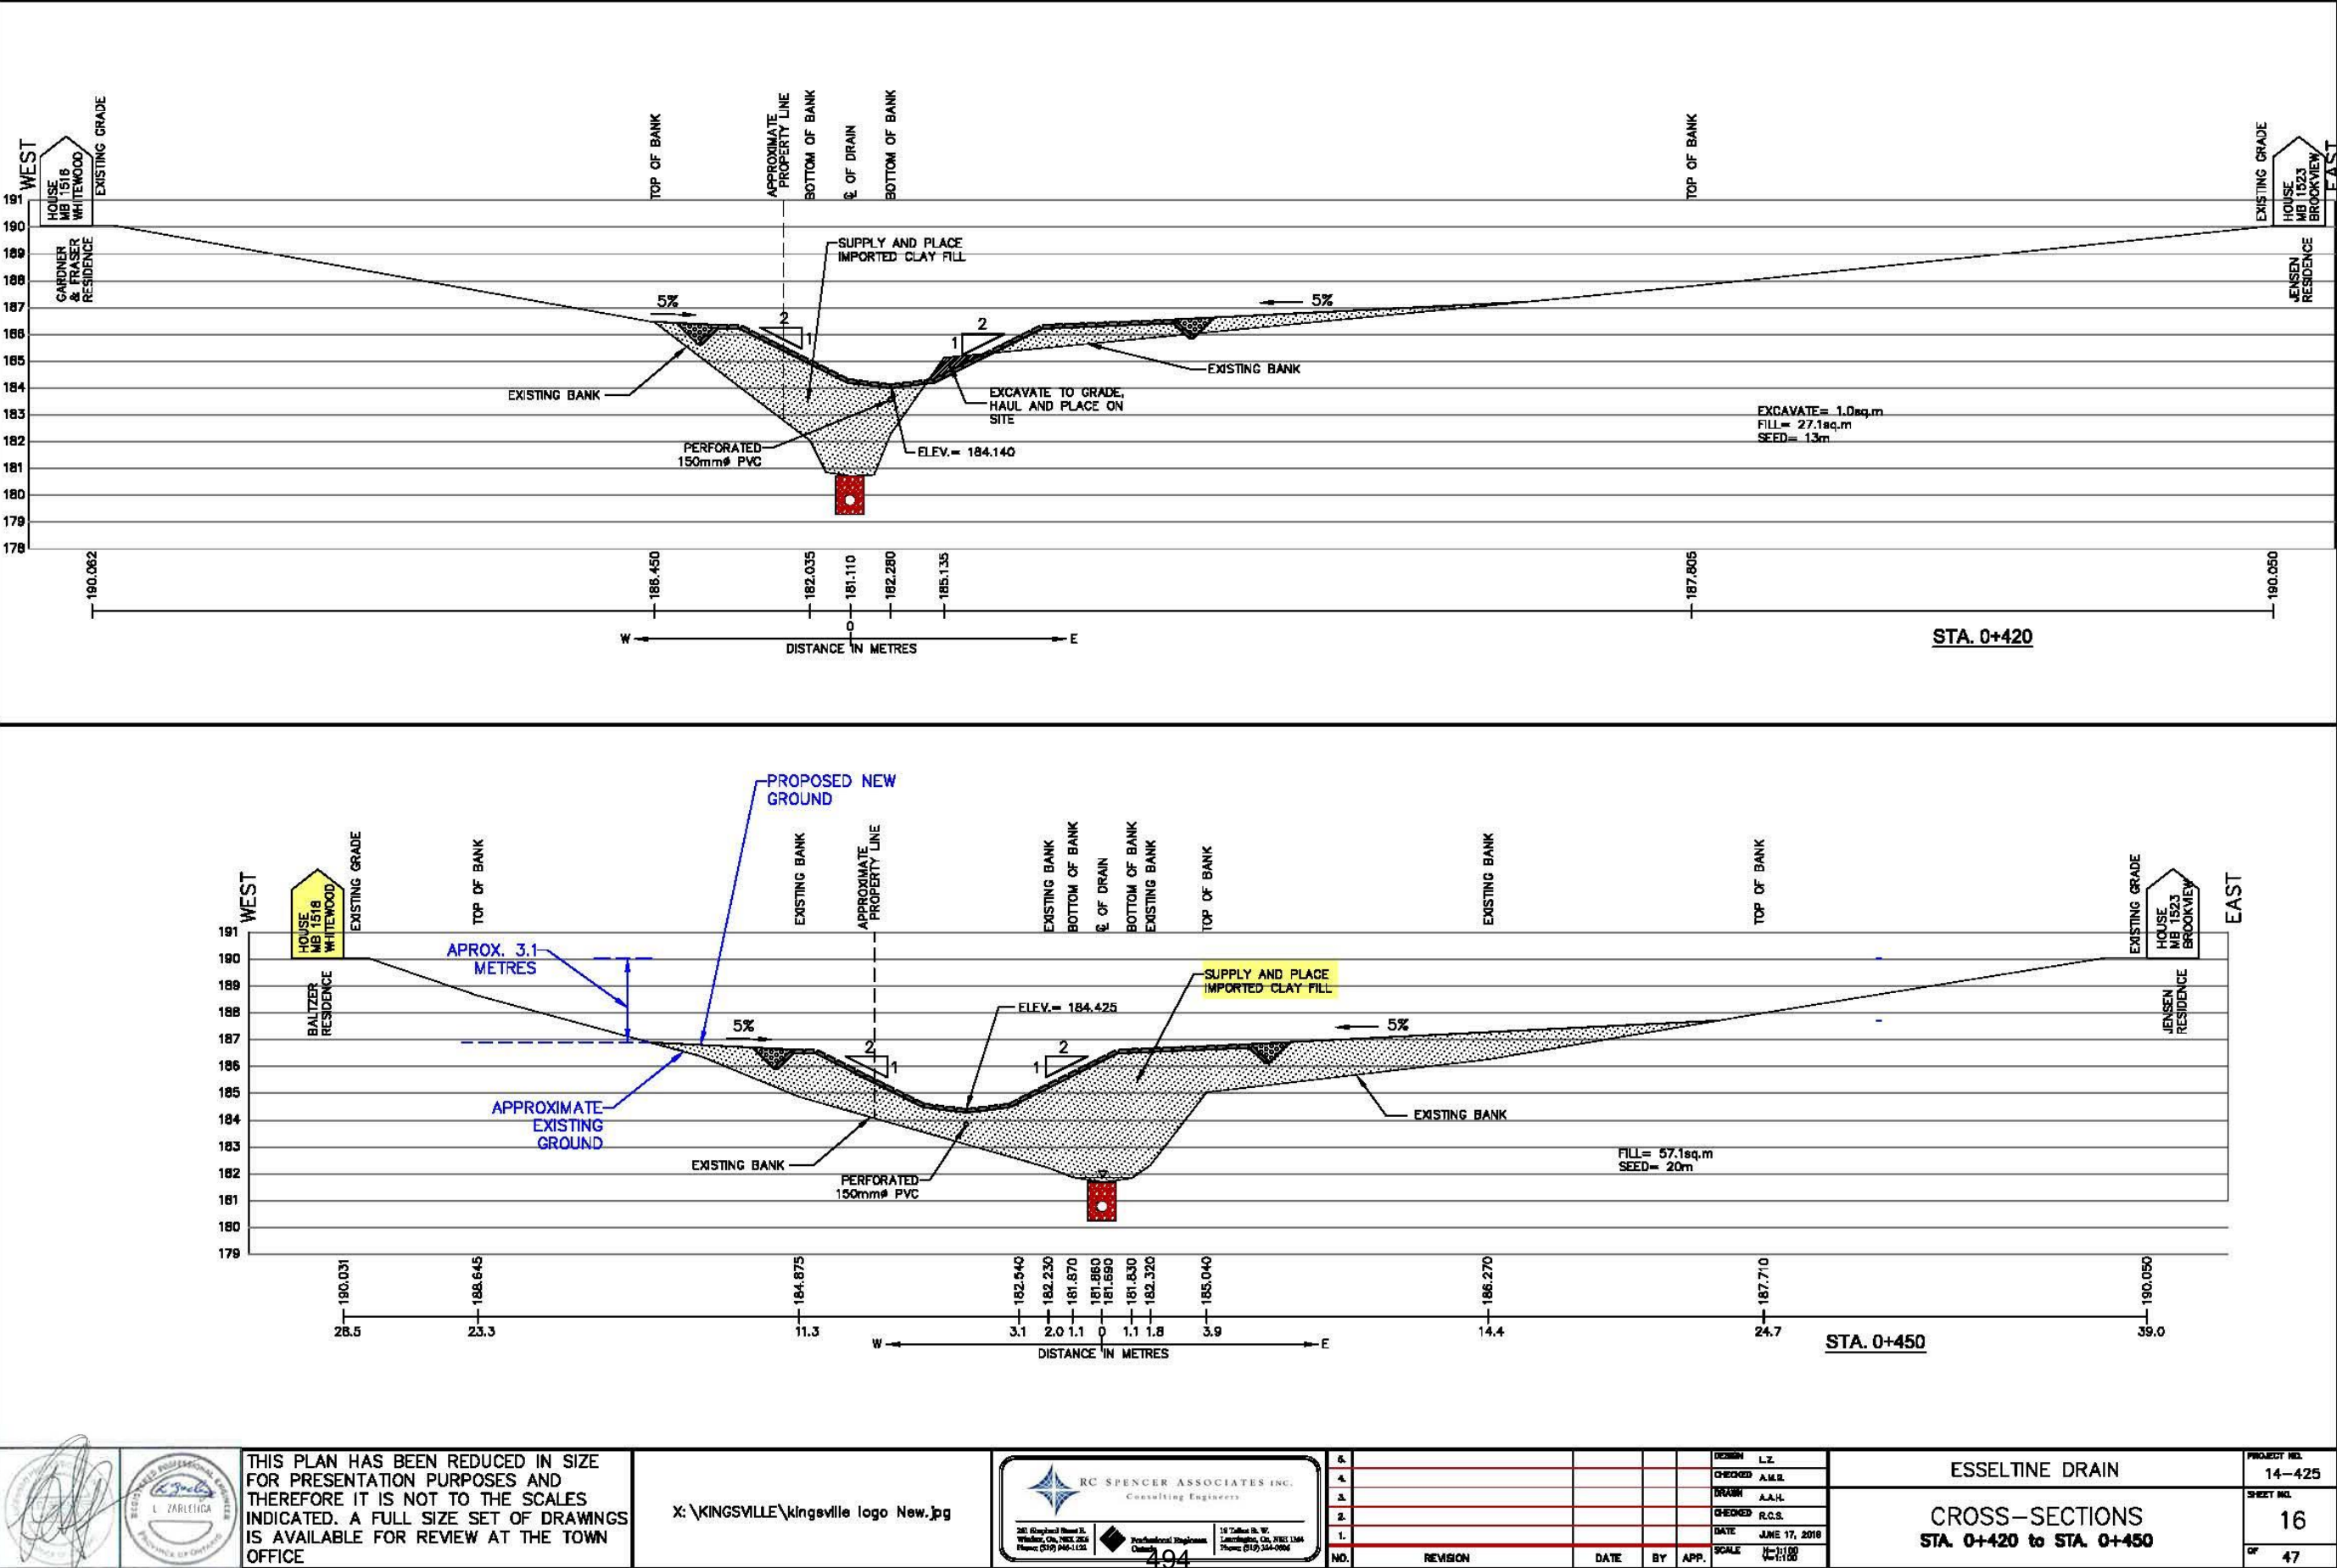
Figure 5: Joni Baltzer – Ravine Cross Section
