Culvert Inspection Report

Mill Creek Scratch Wigle Drain Culvert

Road Name: *McCallum Drive*
 Site ID: *503*
 Structure Type: *Soil-Steel Structure*
 Owner: *Town of Kingsville*
 Built: *1980*
 Length: *21.6 m*
 Width: *3.7 m*
 Spans: *1*
 Spans Arrange: *1 - 3.8*
 Feature Through *Water*
 Crossing: *Wigle Drain*
 Location: *0.1km East of Sumac Drive*

Inspection Date: *August-22-17*
 Inspector: *Steve Reid, C.E.T.*
 Assistant: *Brad Lair, Eng Student*

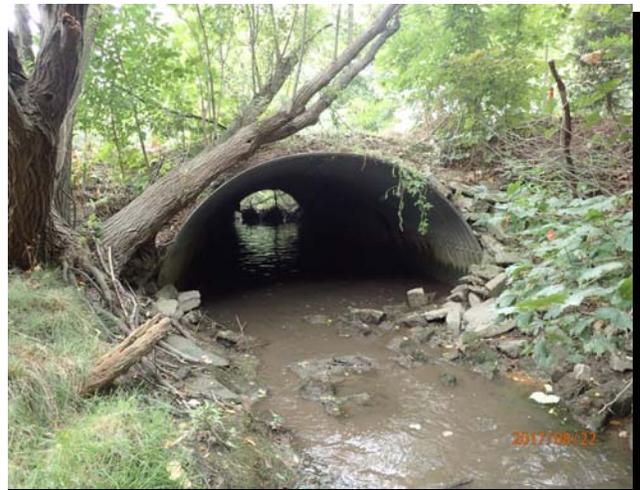
Comments:
Culvert walls are perforated and backfill material is spilling in through perforated areas. If the water levels rise above the perforation line, loss of fill material will increase. Culvert needs immediate replacement as it is at risk of failure under the westbound lane. Regular monitoring of this structure and the pavement in the WBL should be maintained until time of culvert replacement.

Length:	21.6 m	Maintenance	None	
Width:	3.7 m	Capital Rec.	Replace in 1 year	Perf Def: Load Carrying Capacity
Height:	2.2 m	<i>Culvert has perforated along east wall at north end for a length of approximately 5.0m, backfill is spilling into culvert through perforated wall. West wall in similar condition at north end however not as severe. Culvert is in danger of failure under WBL.</i>		
Asphalt Wear Surf (1)		Defects 0.0%		
Wear Surface		Damage 10.0%	Moderate Cracking, Major Potholing	
Length:	20 m	Maintenance	None	
Width:	6.5 m	Capital Rec.	None	
Height:		<i>Pothole in WBL due to loss of fill through perforated culvert wall. Numerous cracks in surface.</i>		
Water Channel (1)		Defects 0.0%		
Conduit Channel		Damage 0.0%		
		Maintenance	None	
		Capital Rec.	None

Recommended Capital Works:
New Conc culvert
