Date: January 8, 2019
To: Mayor and Council
Author: Tim Del Greco, Manager of Municipal Services
RE: 2018 Road Conditions Assessment
Report No.: MS 2019 - 03

To provide Council the results of the latest road conditions assessment.

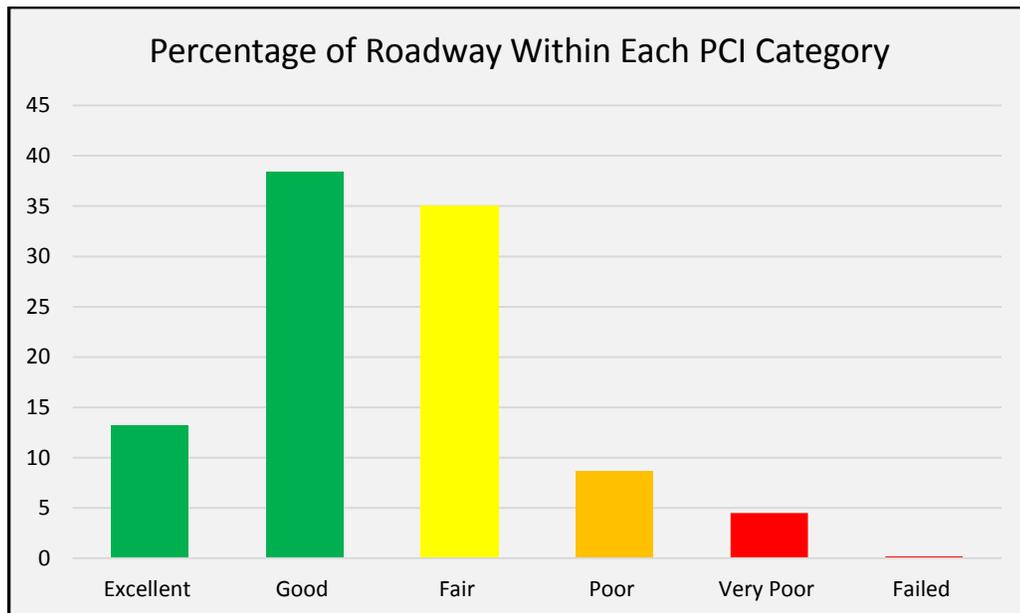
The road assessment was completed and submitted to the Town in December of 2018. The Kingsville Road Network was determined to be in “fair” condition with an average PCI of 68.8. The percentage of roadway within each PCI category is as follows:

PCI Label	PCI range	Number of KM's	%
Excellent	85-100	30.4	13.2
Good	70-85	88.3	38.4
Fair	55-70	80.4	35
Poor	40-55	20.1	8.7
Very Poor	20-40	10.4	4.5
Failed	0-20	0.4	0.2
Total		230	100

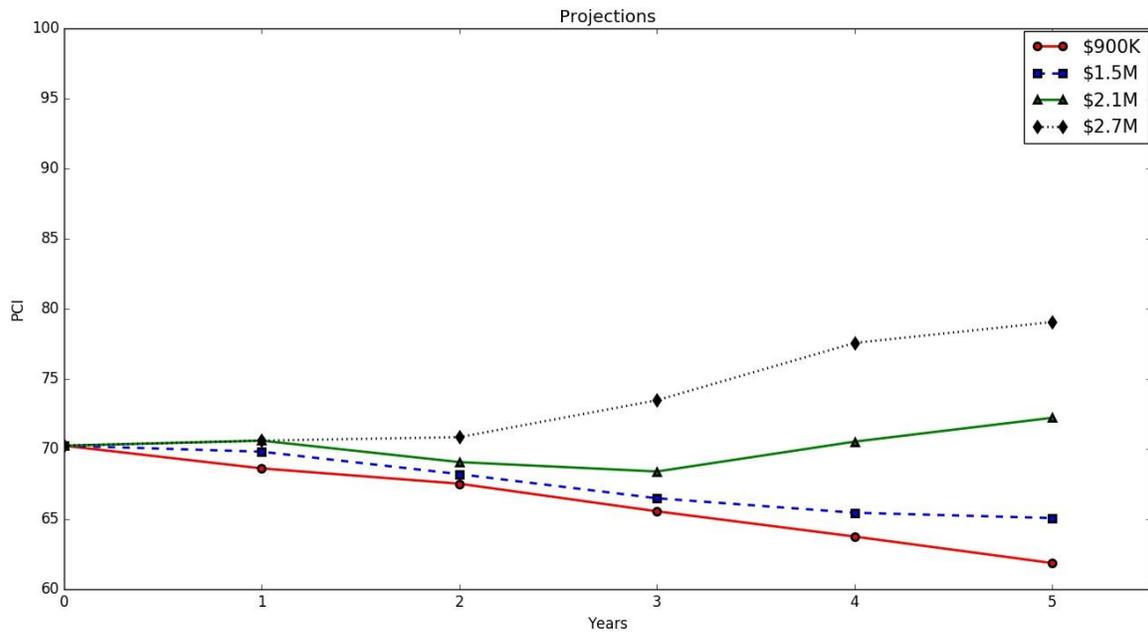
Figure 1: Projected PCI vs Varying Budgets

As part of the latest assessment, StreetScan has completed a projection of future PCI values vs dollars spent per year on road repair. These projections are based on pavement deterioration rates, annual budgets, and the anticipated cost of repairs. Figure 1 below illustrates four different scenarios. The red line, which is representative of the Town's historical annual budget (approximately \$900K), shows a continued decline in road conditions and PCI value. The green line, which represents an annual budget of \$2.1M, predicts sustainability of our road network over a five year period at a PCI value of 70.

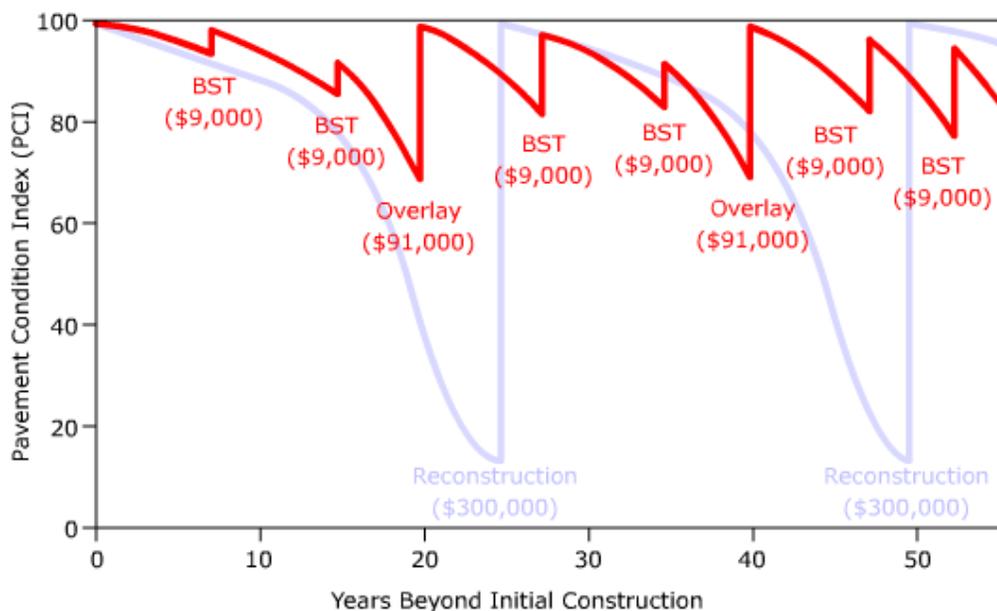
Figure 2: Effects of Maintenance and Repair on a Pavement Life Cycle Comparison Based on Cost Per Mile of a Two Lane Road

In addition to sustainability, increased spending is more economical in the long term as full road reconstruction is exponentially more expensive than maintenance and repair. This concept is further illustrated in Figure 2 below.

No Maintenance
Total cost = \$600,000 per lane mile

Maintenance
Total cost = \$276,000 per lane mile
