LAS Roads Assessment Service

Roads Asset Management Plan

StreetScan was contracted by the Town of Kingsville to assess the conditions of 230.0 centerline kilometers of Town-maintained roads. This final report is a comprehensive account of the project scope and schedule, StreetScan's methodology, and StreetScan's findings in the Town.

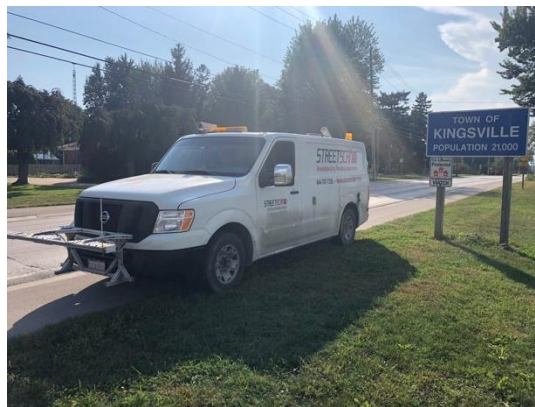
Figure 1. ScanVan

StreetScan's ScanVan system was used to identify distresses in the roadway which impact the PCI rating. Distresses are extracted from the 3D imaging sensors. These distresses include cracking features, surface texture features, pothole features and bump and depression features.

StreetScan utilized our custom ScanVan system, which allows for rapid data collection without the need to close roads, so data collection can proceed at the given speed limit. The ScanVan utilizes 3D imaging sensors combined with optical cameras. Surface distresses are identified using data from the 3D imaging sensors. A combination of features extracted from the 3D imaging sensors are used to identify distresses in the roadway which impact the PCI rating, generating a data-driven PCI conditions inventory for assessed road segments.

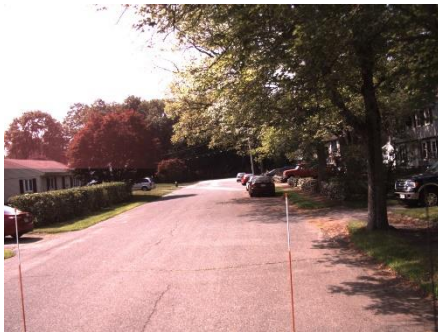
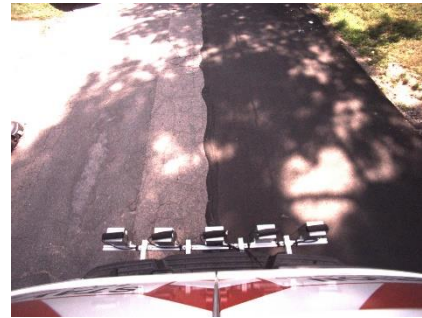
Figure 3. Sample front and rear camera images

Two high-resolution camera systems are installed on the StreetScan ScanVan: a surface (pavement) facing camera and front facing camera. The imagery from these cameras are used in the QC (Quality Control) process to verify the predicted PCI values. In addition, other asset information can be extracted from the

images from these camera systems and provided to the customer; such as pavement markings, manhole locations and road sign inventory.

Front Camera View

Surface Camera View

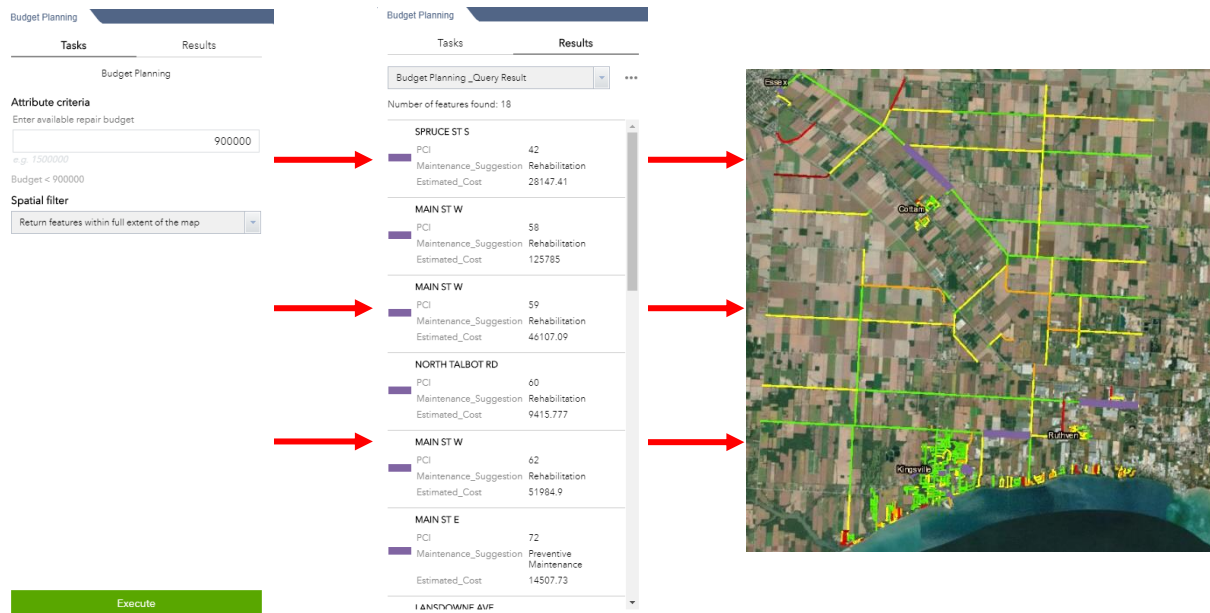
Figure 7. Sample PavEMON screengrab, budget scenario tool

Custom reports are created by the Town of Kingsville to test budget scenarios, develop pavement management plans, and create graphics and statistics. Portal training was provided to the Town and ongoing support is provided. Below is an example of the functionality provided by the software.

The user can create pavement management plans and reports utilizing different budget scenarios. This can be applied to different spatial distances. For example, the Town could decide to run a budget scenario utilizing the Town-wide PCI data or the data for a specific neighborhood only. In addition, segments can be filtered out utilizing specific attributes such as existing road condition, functional class, or surface type (pavement or surface treatment) to yield unique plans that are custom to the Town. These reports can be exported in a tabular format, GIS shapefile, or feature data-layer that can be stored in the web portal. These feature data-layers can then be used to create data-driven statistics, maps, and graphics.
