# 2017 BRIDGE & LARGE CULVERT BIENNIAL INSPECTIONS

Town of Kingsville

**Keystone Bridge Management Corp.**

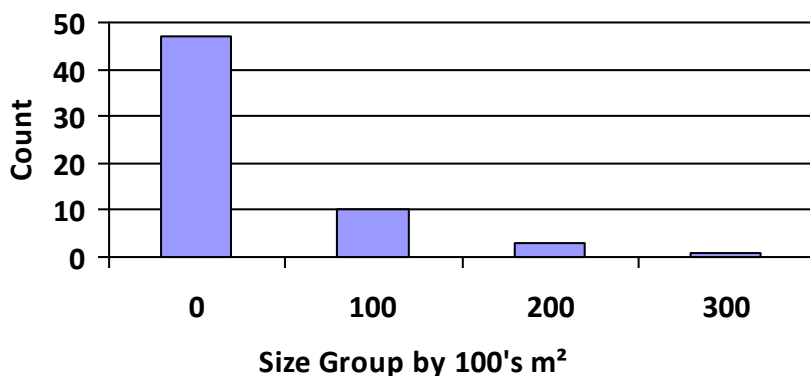
## Structure Deck Area Histogram

Average Deck Area	83 m²
Min Deck Area	15 m²
Max Deck Area	400 m²
<b>Total Deck Area</b>	<b>5,060 m²</b>

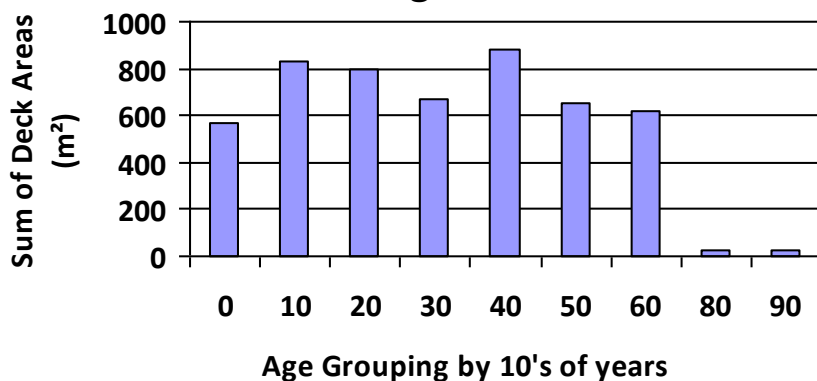
## Structure Deck Area by Age Histogram

Deck area < 20 yrs old	1396 m²
Deck area < 50 yrs old	3739 m²
Deck area > 50 yrs old	1321 m²

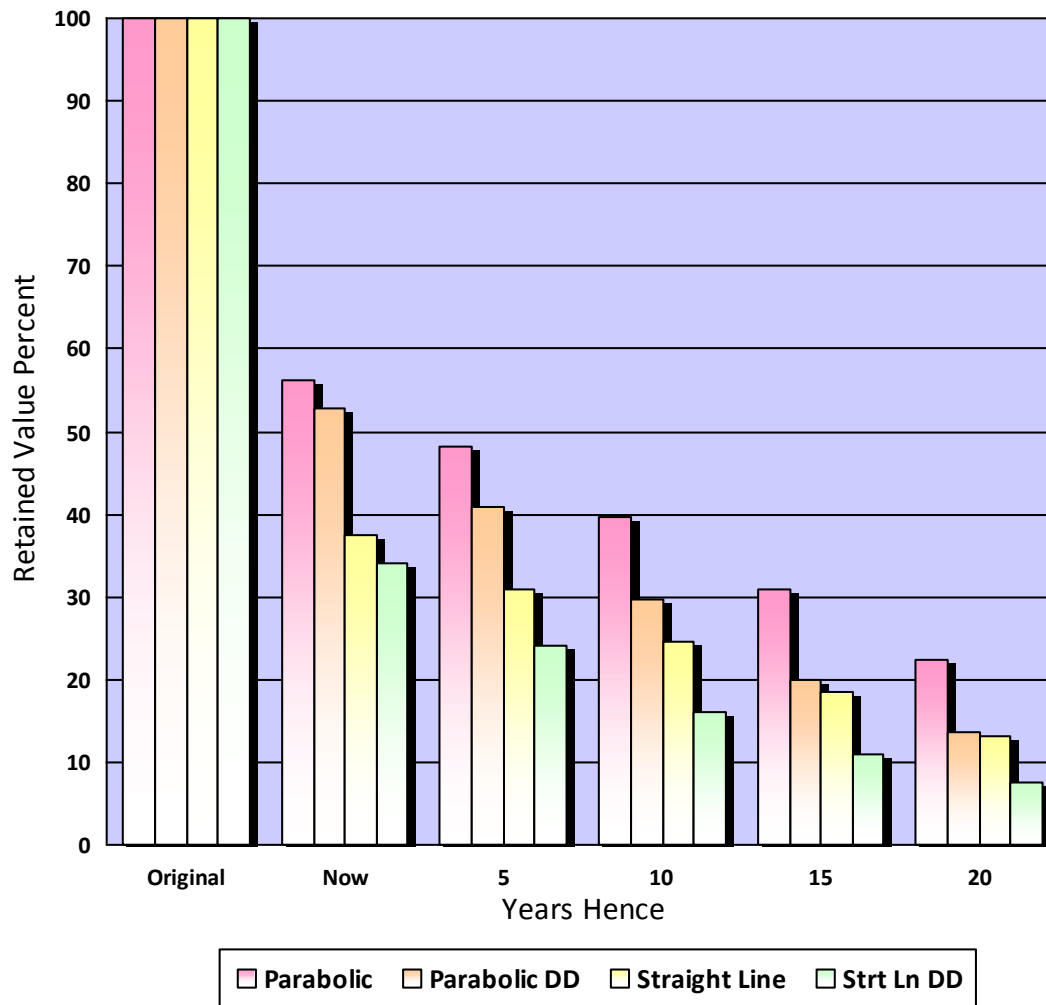
## Forecast Bridge Value - No Investment

- Parabolic: Parabolic Depreciation not including effects of Defects & Damage
- Parabolic DD: Parabolic Depreciation including effects of Defects & Damage
- Straight Line: Straight-Line Depreciation not including effects of Defects & Damage
- Strt Ln DD: Straight-Line Depreciation including effects of Defects & Damage

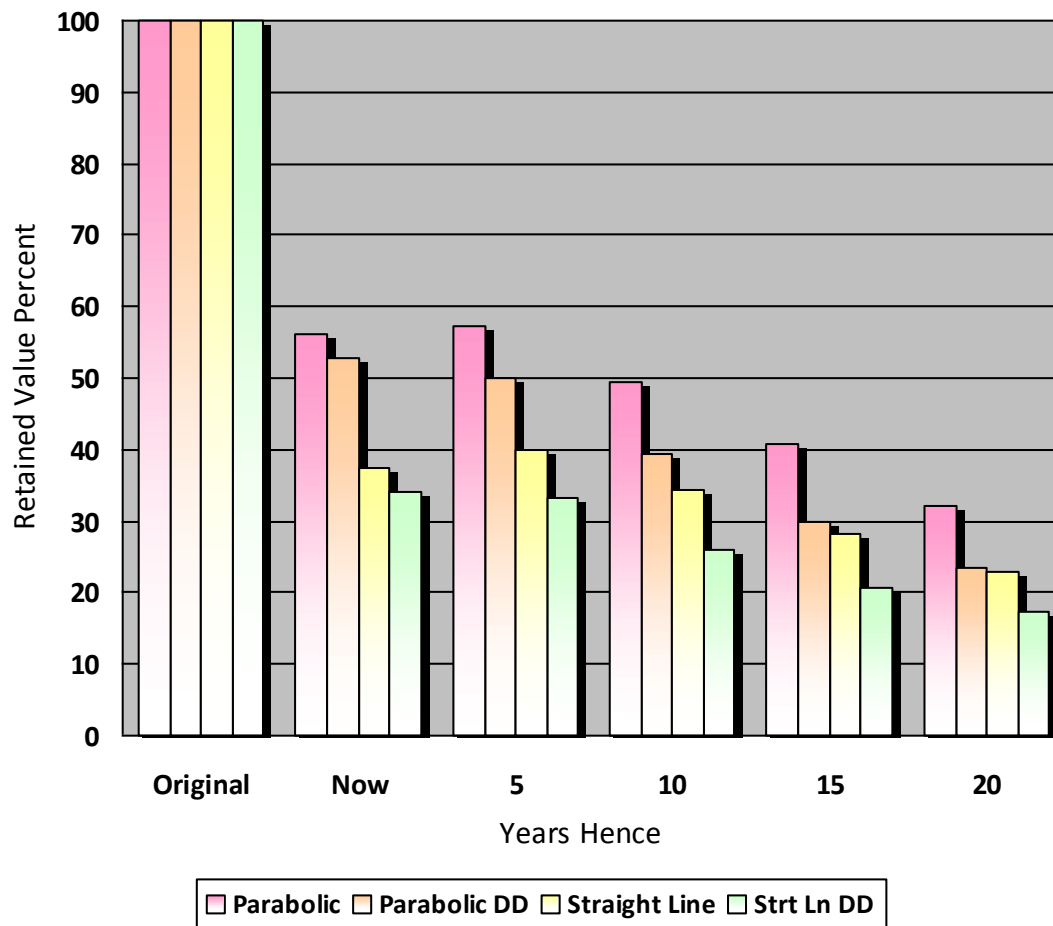
## Forecast Bridge Value with Investment

- Parabolic: Parabolic Depreciation not including effects of Defects & Damage
- Parabolic DD: Parabolic Depreciation including effects of Defects & Damage
- Straight Line: Straight-Line Depreciation not including effects of Defects & Damage
- Strt Ln DD: Straight-Line Depreciation including effects of Defects & Damage
